# HAZUS Tsunami Benchmarking, Validation and Calibration

**Ronald T. Eguchi  
Michael T. Eguchi  
Jawhar Bouabid  
Shunichi Koshimura  
William P. Graf**

**July 8, 2013**

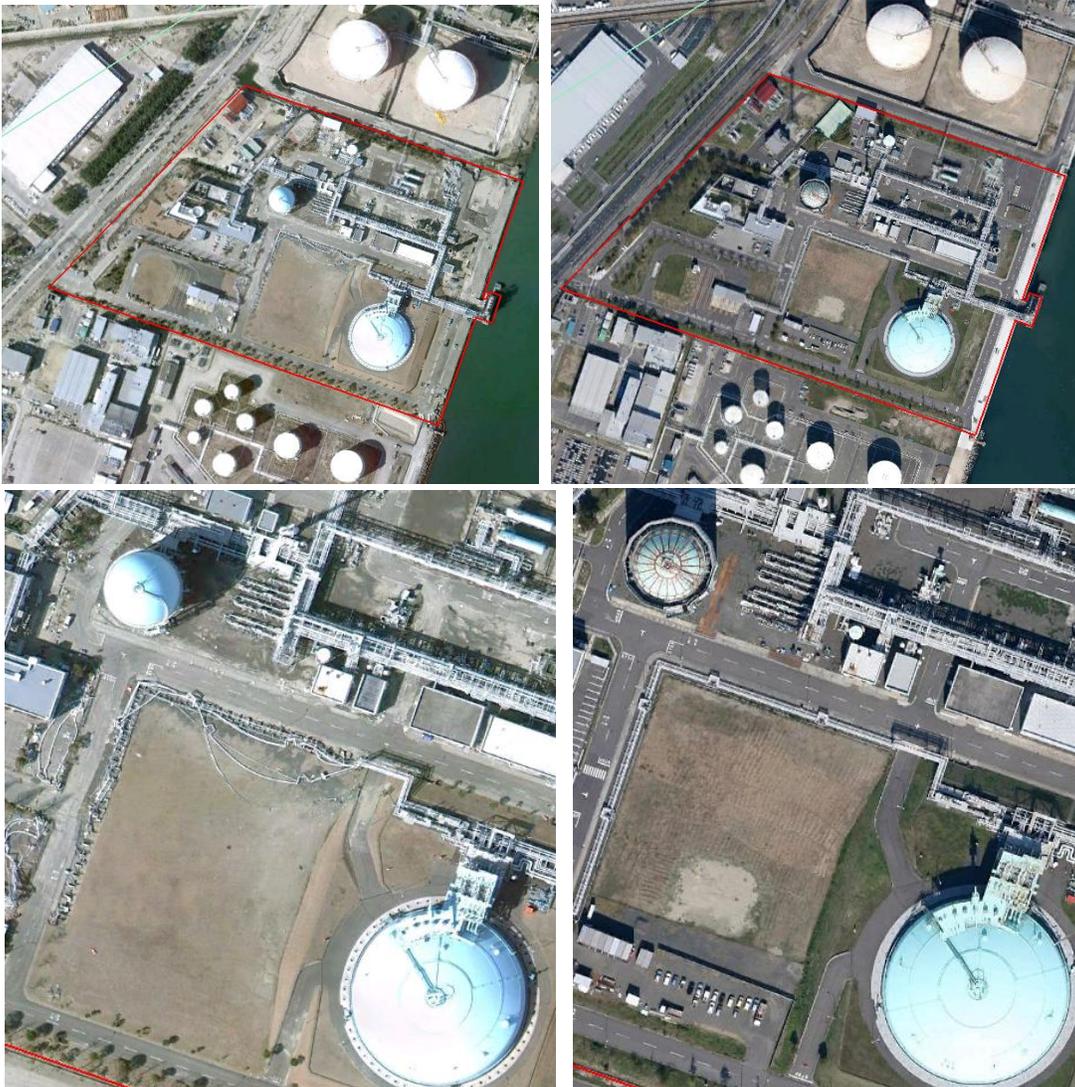
**ID:** 2

Comments: Post event imagery from 4/6/11 shows no complete failure of structures within the facility. Piping has been repaired/replaced in imagery from 8/19/12 suggesting damage was repairable and not a complete loss. Intermediate imagery between the two dates shows no signs of demolition.

Top Left: Post-event imagery from 4/6/11. Top Right: Post-event imagery from 8/19/12  
Bottom Left: Zoomed in view of broken piping (4/6/11). Bottom Right: Zoomed in view of repaired piping (8/9/12)

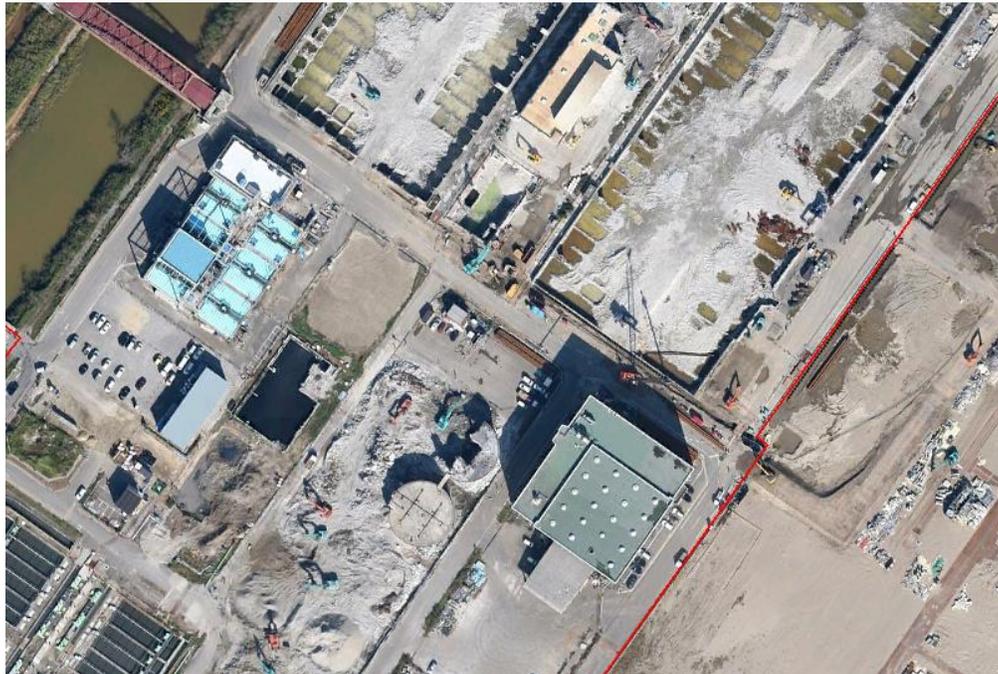
**Comments:** Most structures still standing immediately following the event (imagery date 4/6/11), however, demolition of a few building and all tanks is apparent in imagery from 8/19/12.

Top Left: Pre-event imagery from 4/4/11. Top Right: Post-event imagery from 8/19/12),  
Bottom: Zoomed in view of post-event imagery showing demolition in process

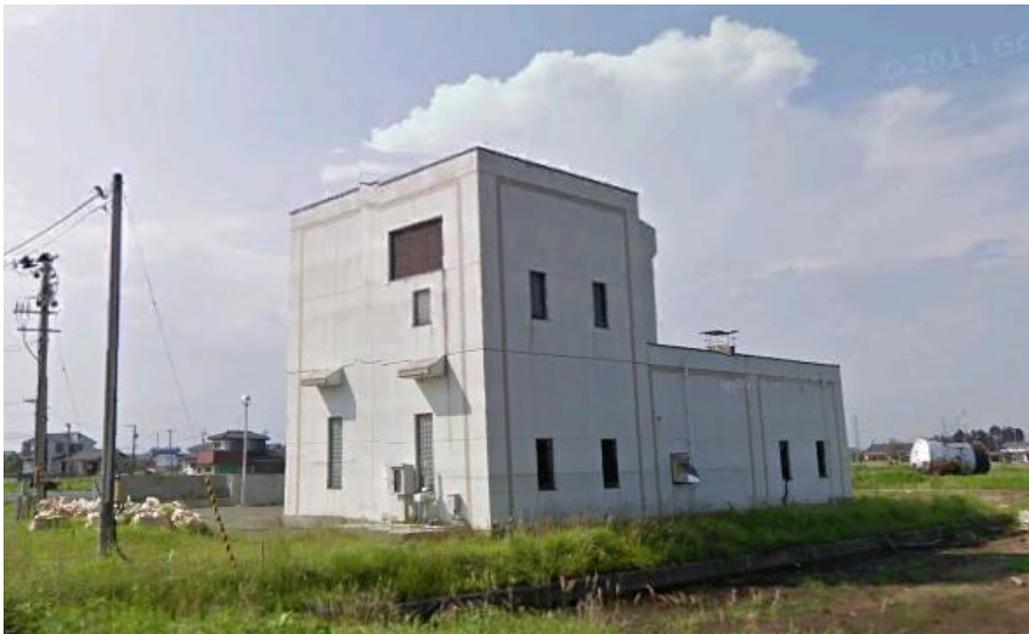
**Comments:** No heavy damage visible immediately following the tsunami. No sign of demolition. Appears skylight has been repaired and cars are in the lot suggesting building is functional (or soon to be).

Top Left: Post-event imagery from 4/6/11. Top Right: Post-event imagery from 8/19/12.  
Bottom: Ground photo of facility (No heavy damage visible).

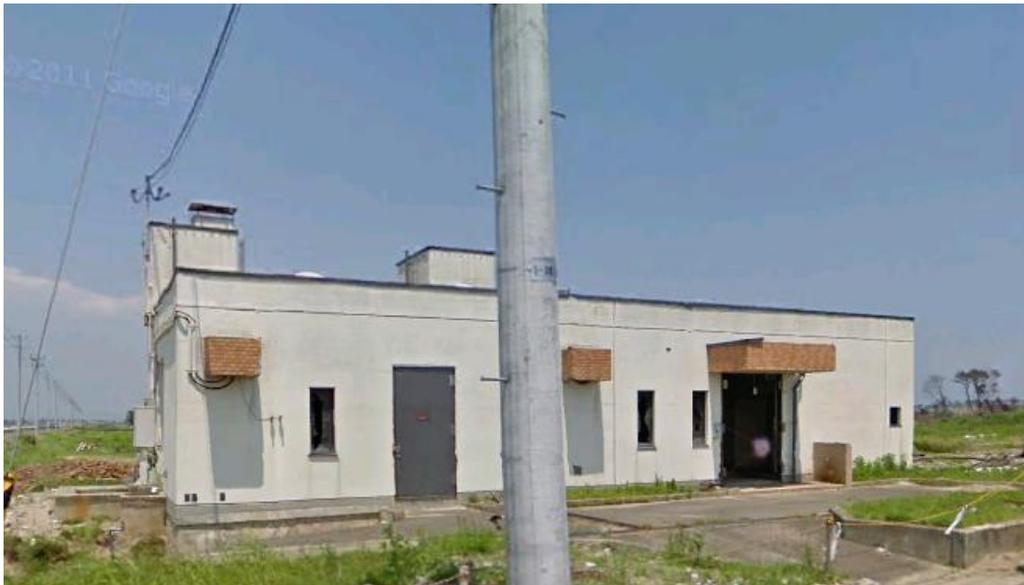
**Comments:** Heavy damage following the tsunami, however it appears the structure has been repaired with no evidence of a demolition.

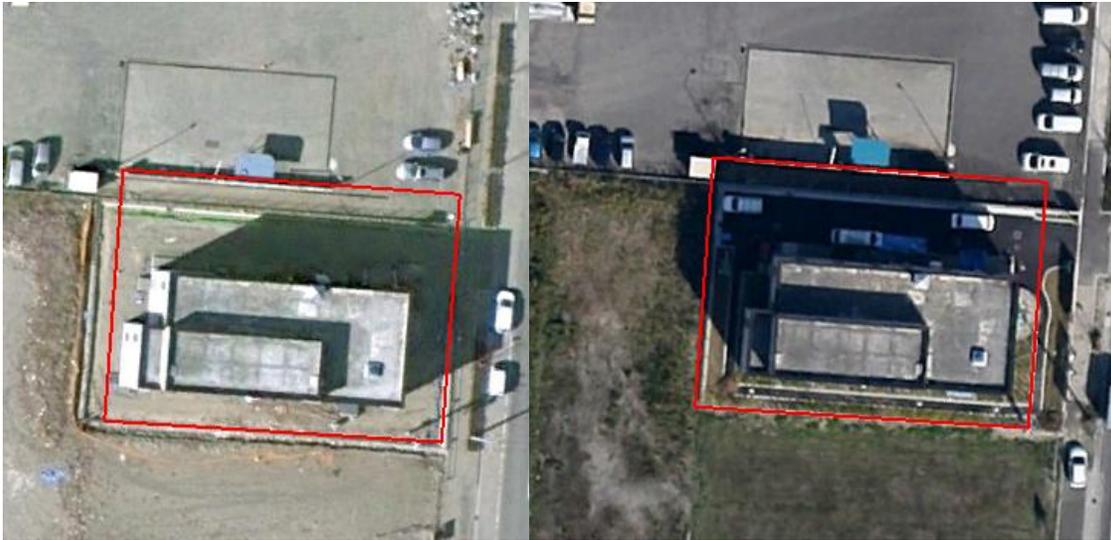
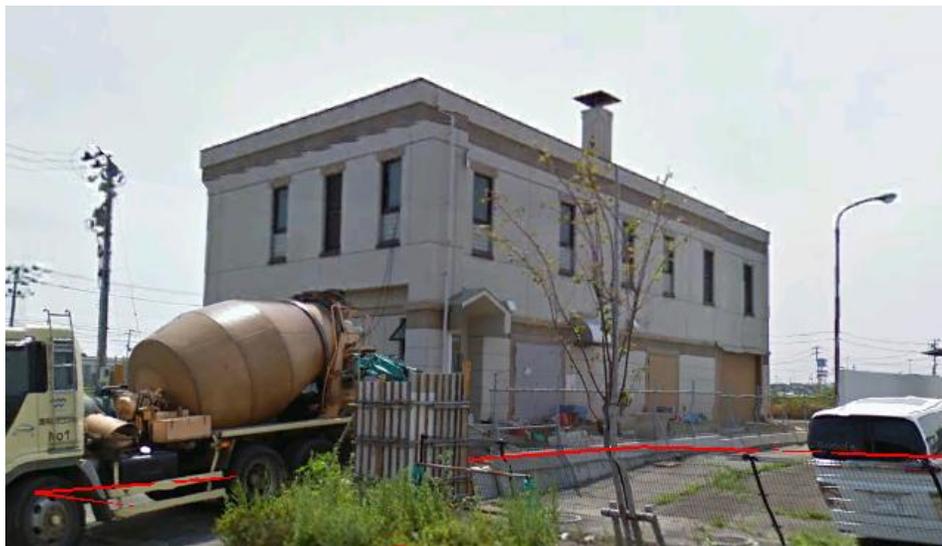
**Comments:** Appears the structure has been repaired.

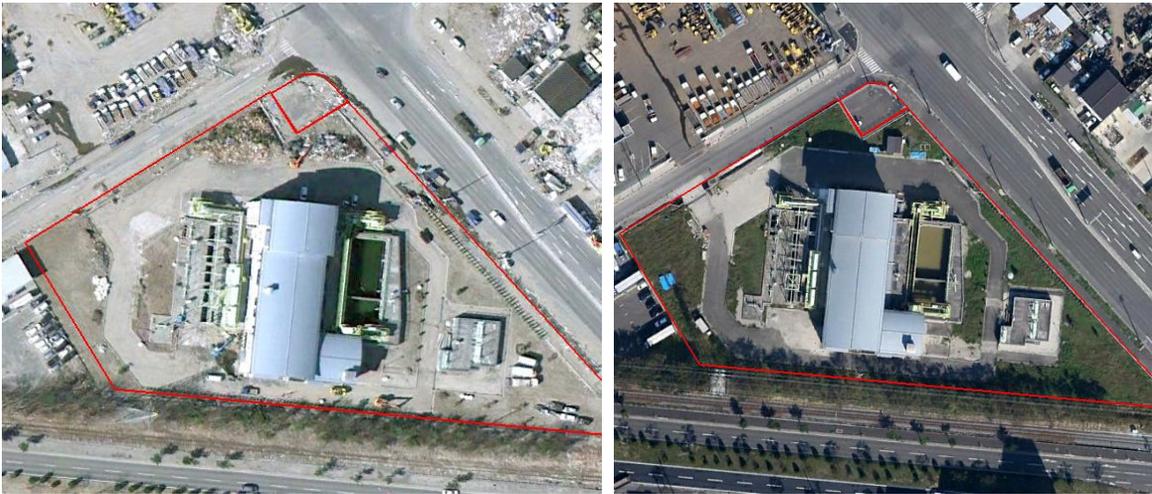
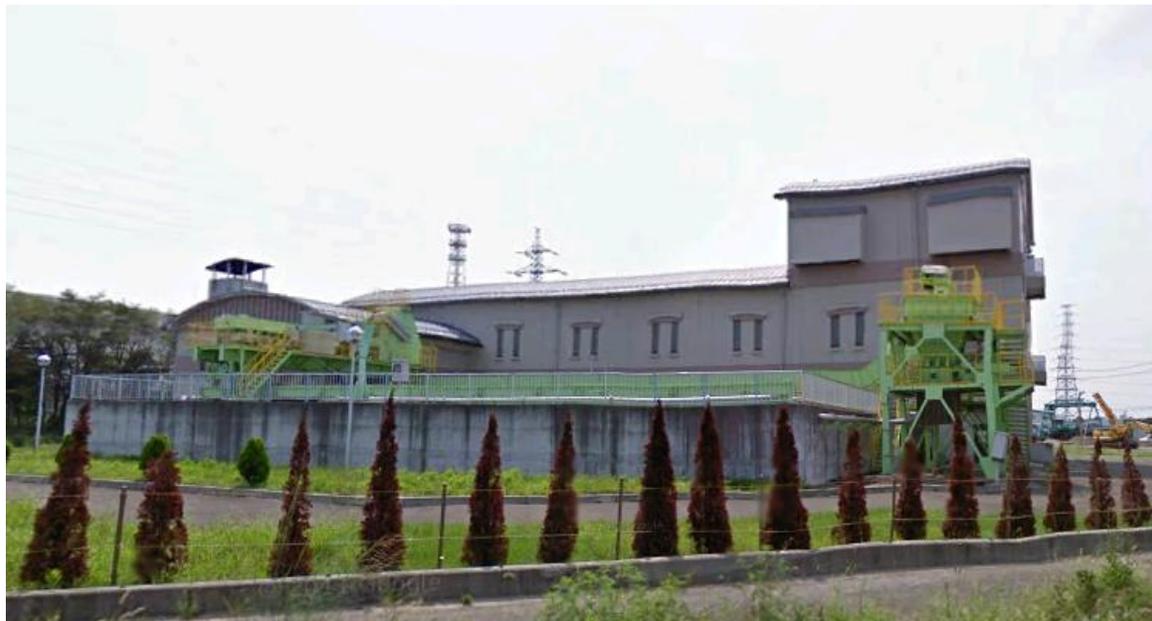
**Comments:** No heavy damage evident post-disaster. Debris has been cleaned up and the structure appears to have been repaired from satellite imagery and ground photos.

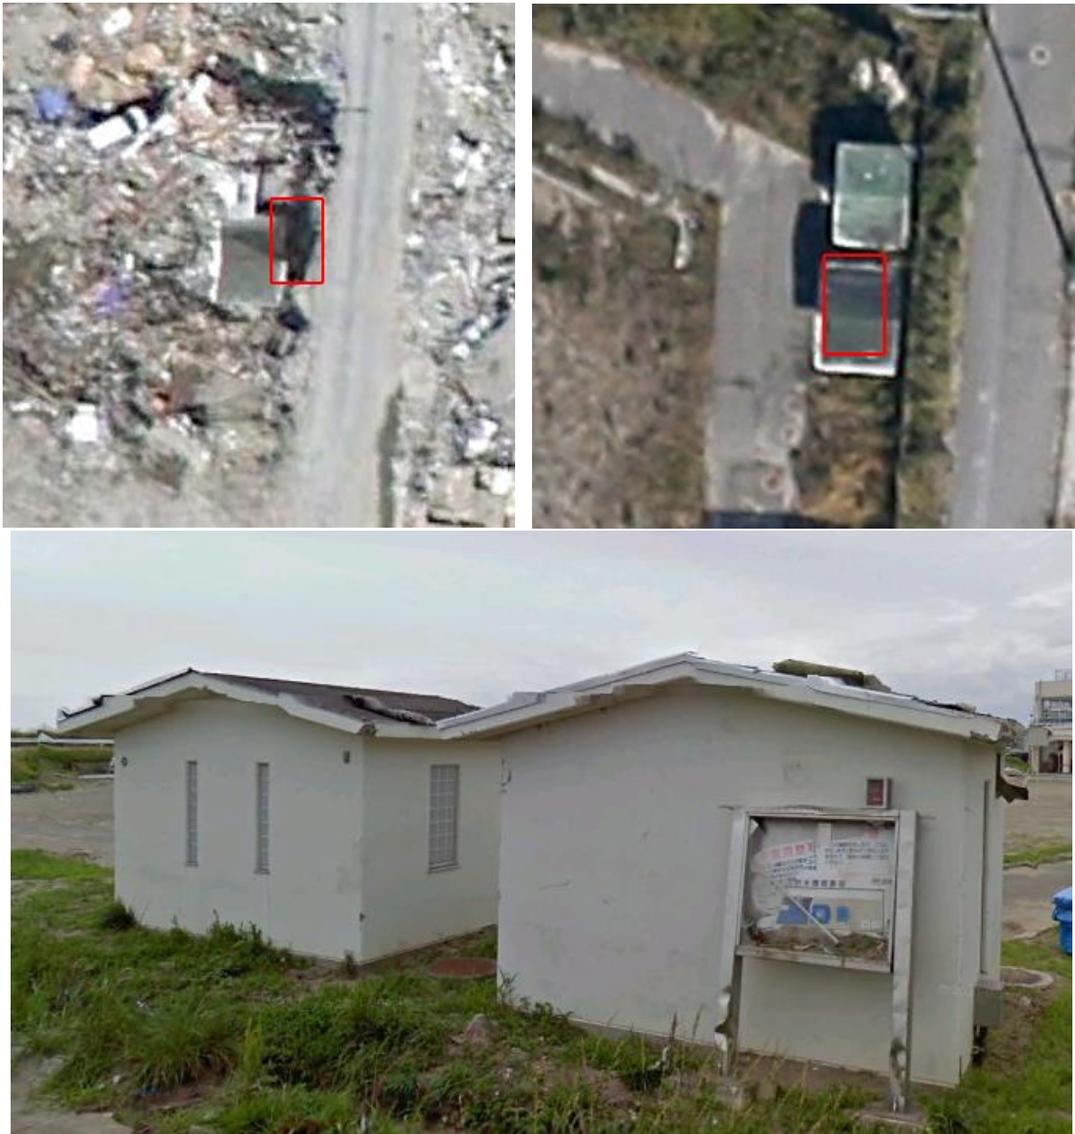
**Comments:** Post-event imagery from 4/6/11 show heavy debris and a partially collapsed roof. No structures around survived. It appears the structures have been rebuilt from imagery taken on 8/19/12.

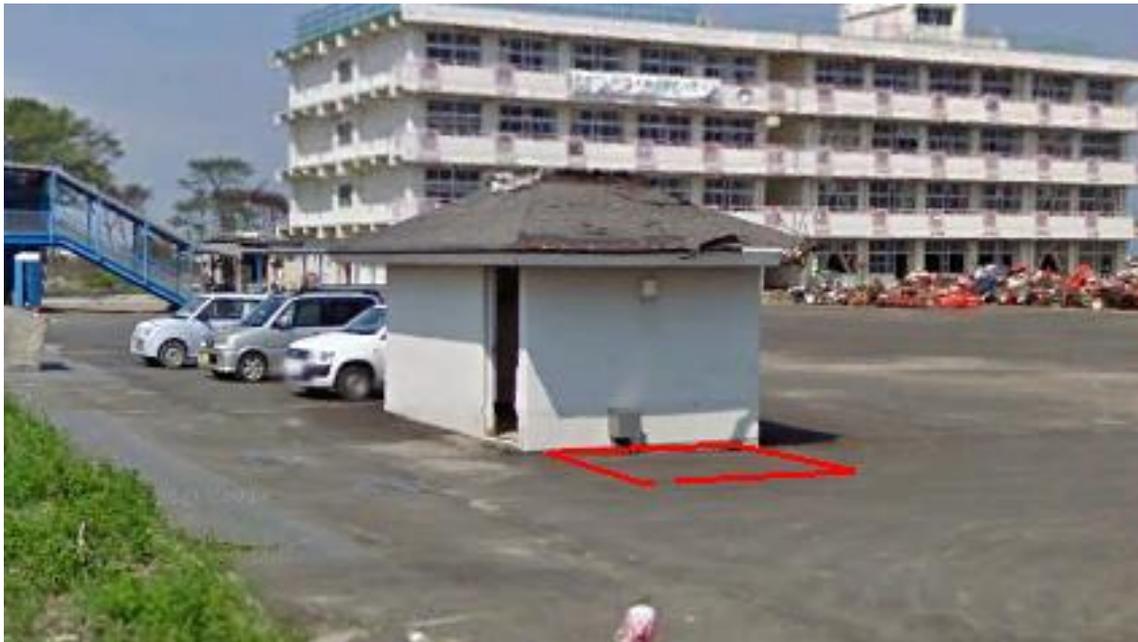
**Comments:** Heavy debris surrounding the structure. It appears repairs have been made from post-event imagery and ground photos.

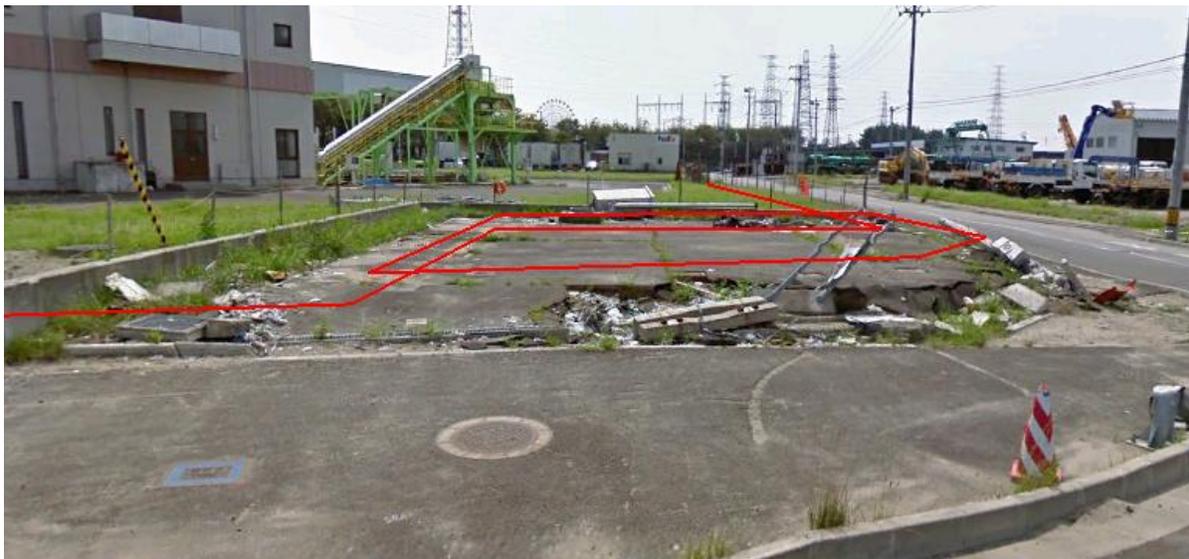
**Comments:** Collapse based on post-event imagery (4/6/11) and ground photos (only the foundation remains). It has since been rebuilt, based on imagery from 8/9/12.

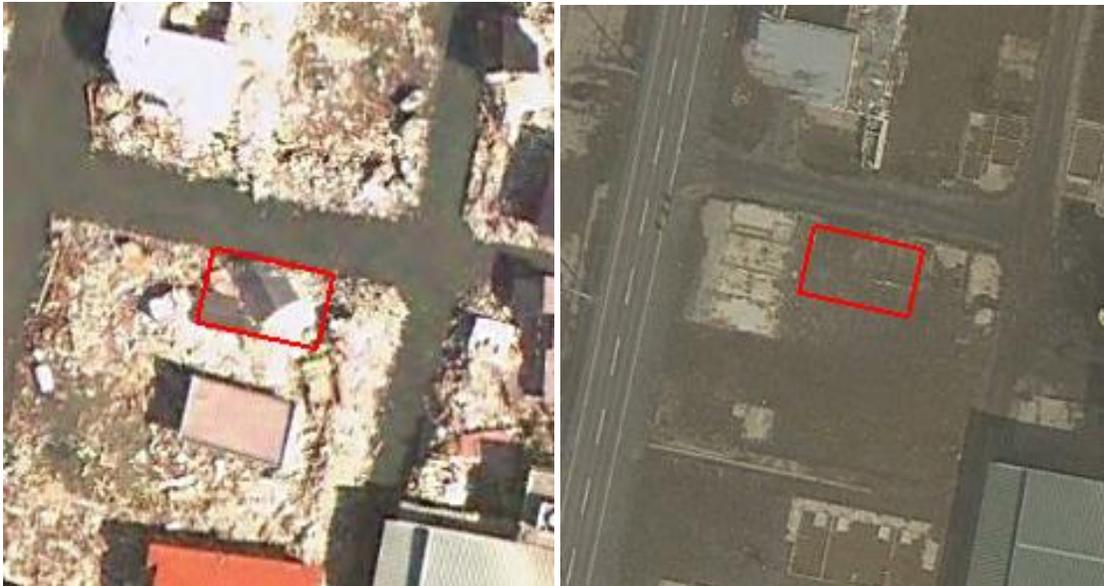
**Comments:** Structure showing signs of obvious collapse in post-event imagery.

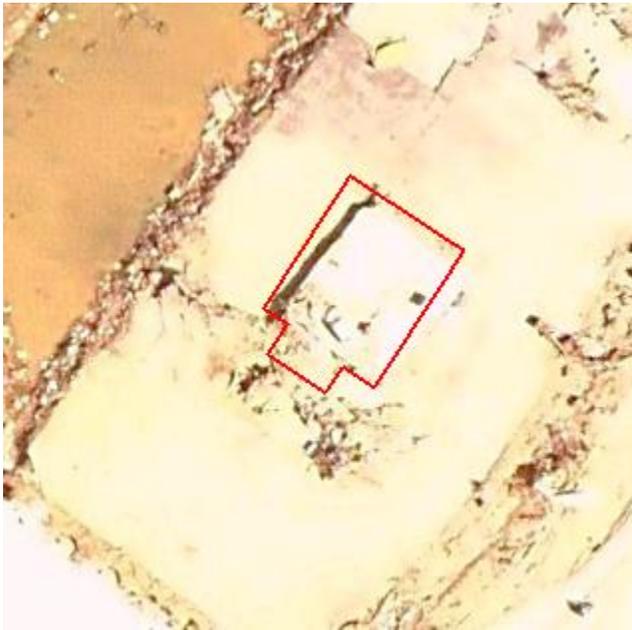
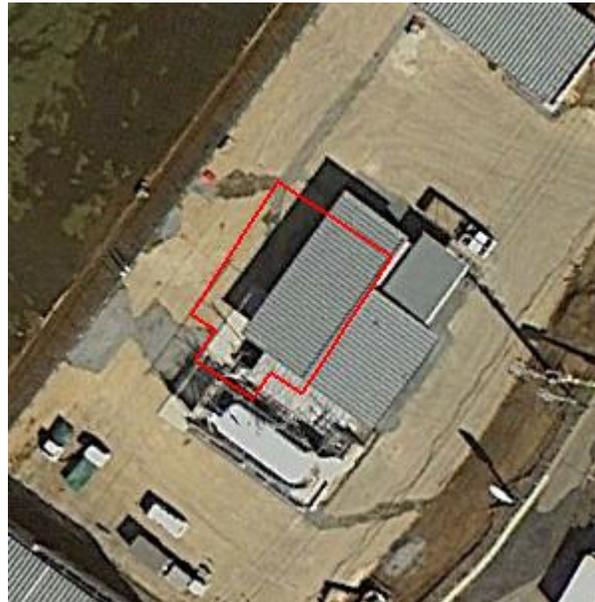
**Comments:** The structure has almost been completely washed away as evident in the post-event imagery from 4/6/11. Imagery from 3/19/12 shows a rebuilt structure.

Left: Post-event imagery from 4/6/11. Right: Post-event imagery showing rebuilt facility from 3/19/12.

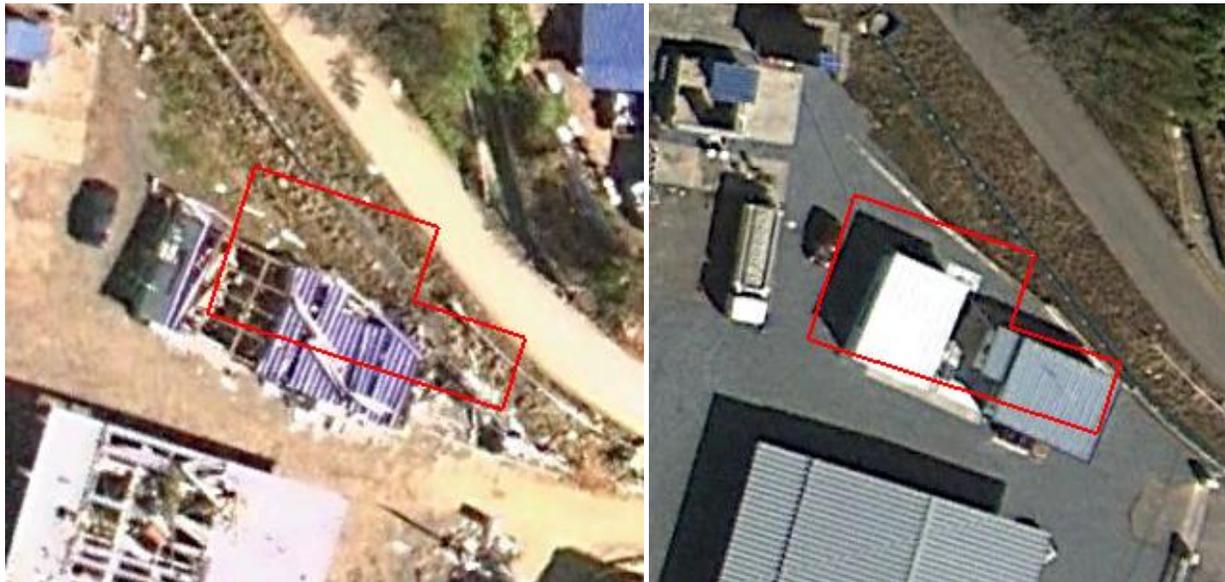
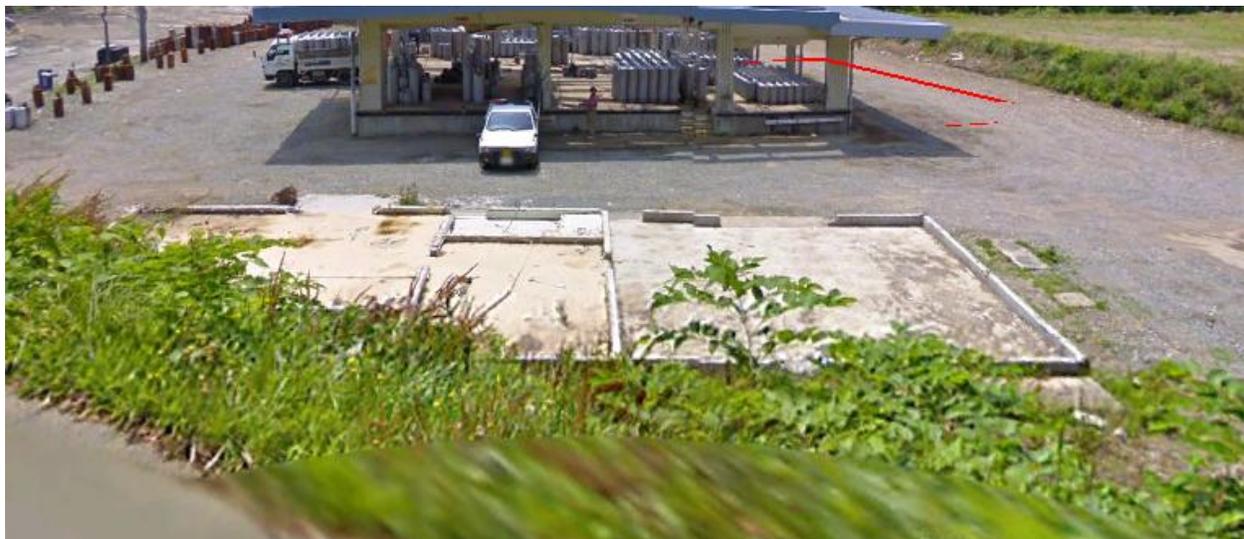
**Comments:** No pre-event imagery is available for this area, however the structure shows a significant amount of damage in post-event imagery (4/6/11). Collapse of roof and exterior wall damage is visible. Imagery from 3/19/12 shows a rebuilt structure. Only the foundation is visible in street view.

Top Left: Post-event imagery from 4/6/11. Top Right: Post-event imagery from 3/19/12 showing rebuilt structure.  
Bottom: Post-event ground photo verifying complete loss (only the foundation is left)

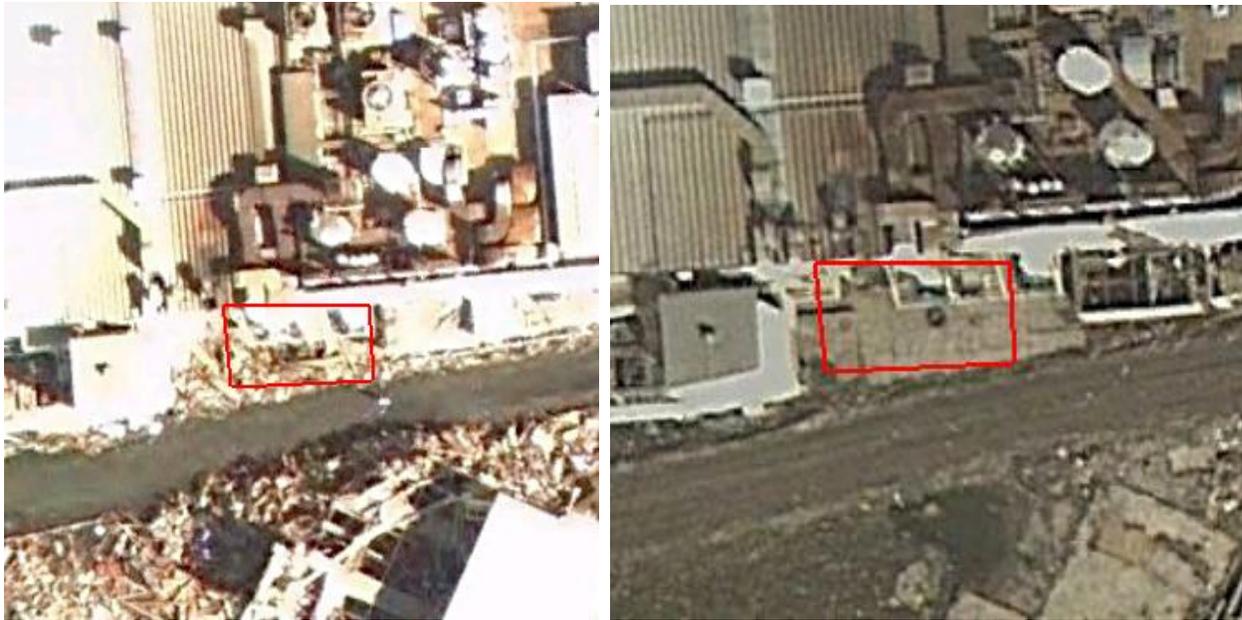
Left: Post-event imagery from 4/6/11 showing heavy debris. Right: Post-event imagery from 3/19/12.

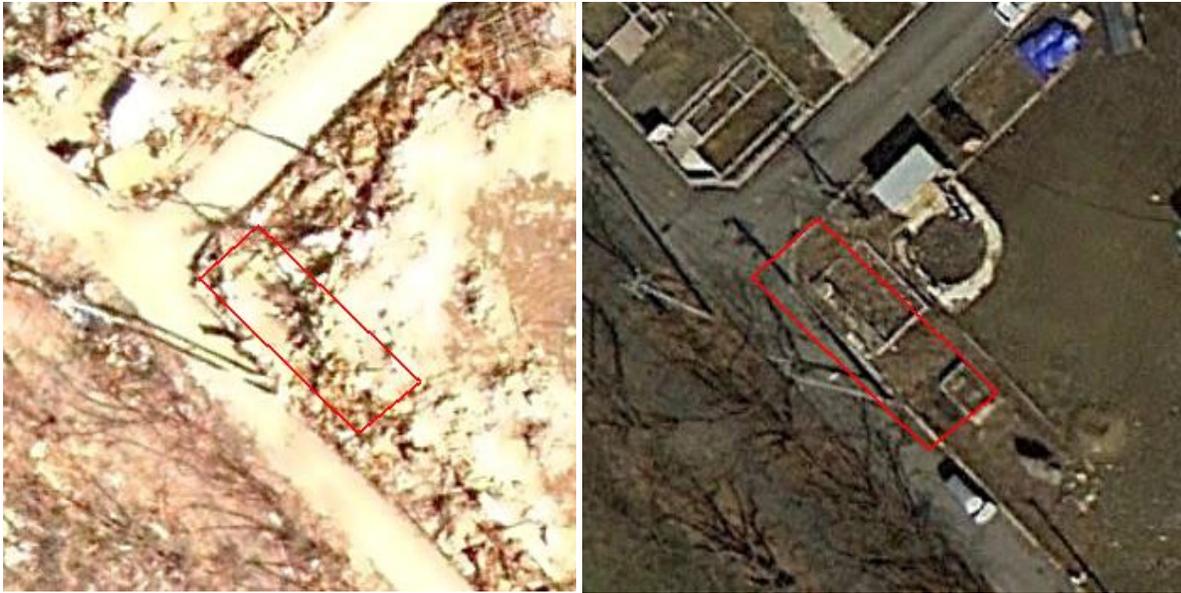
Left: Post-event imagery from 4/6/11 showing washed away facility. Right: Post-event imagery from 3/19/12.

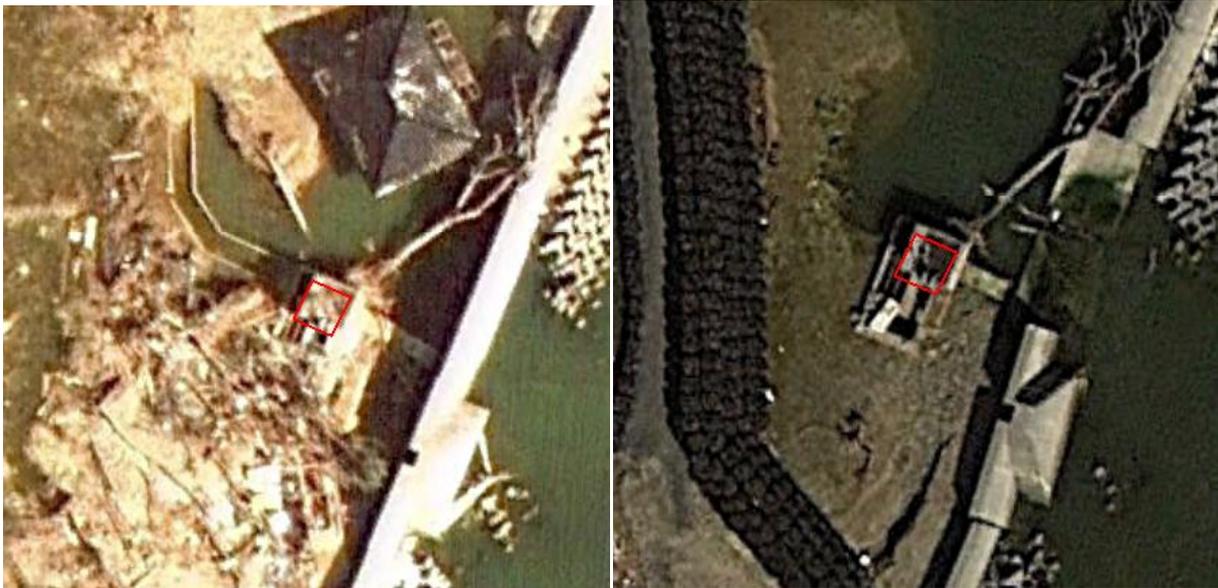
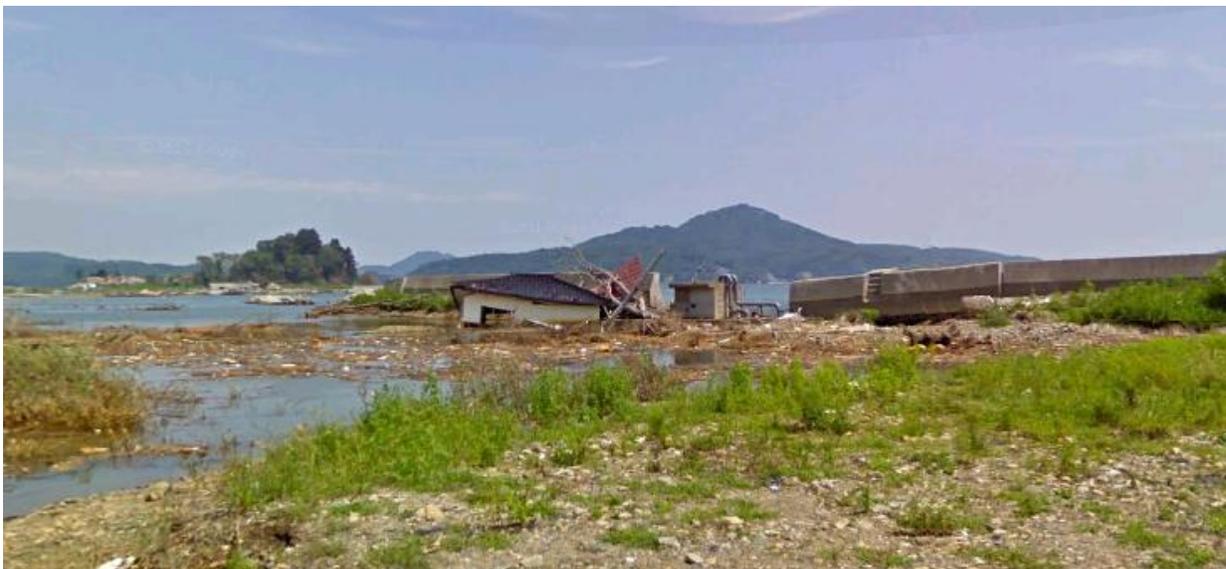
Top Left: Post-event imagery from 4/6/11. Top Right: Post-event imagery from 3/19/12 showing no obvious repairs  
Bottom: Post-event ground photos showing extent of damage

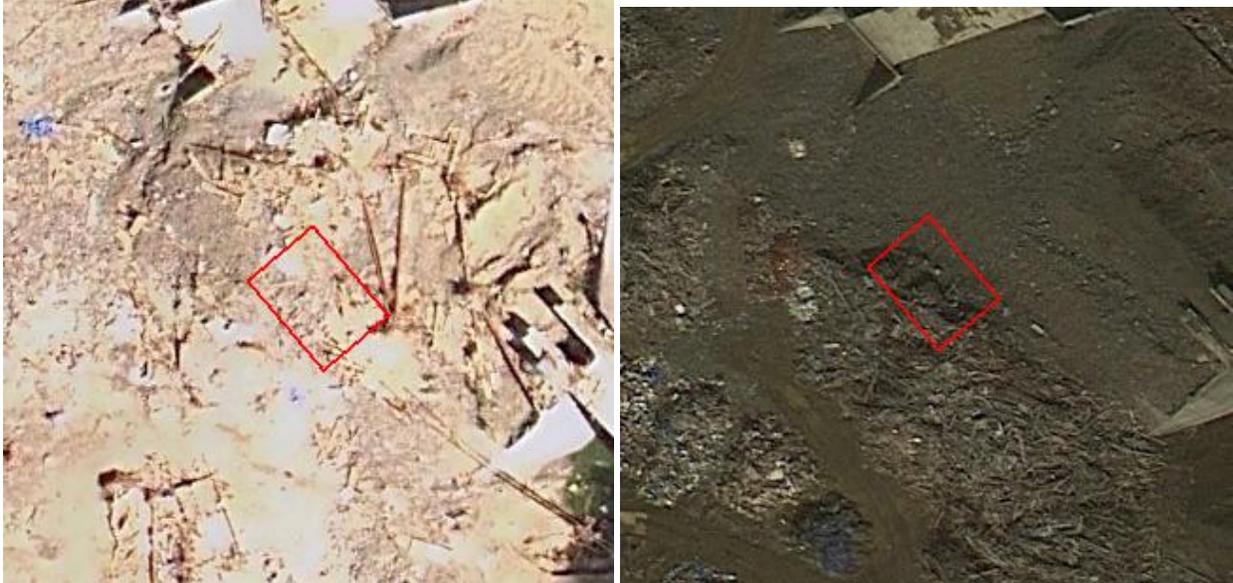
Left: Post-event imagery showing washed away facility from 4/6/11. Right: Post-event imagery from 3/19/12.

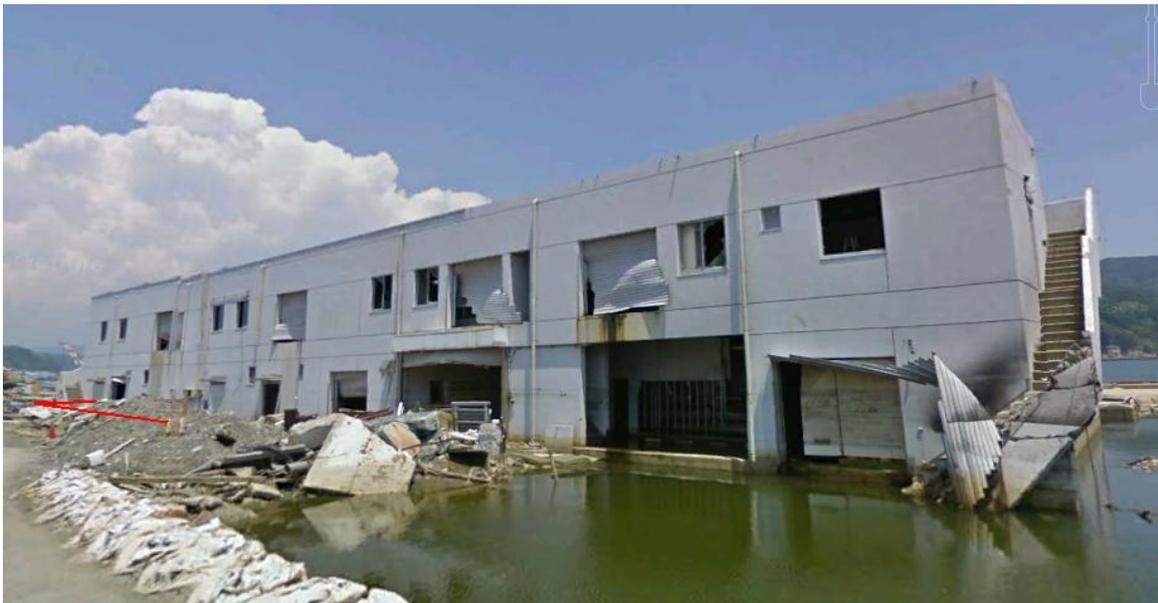
Top Left: Post-event imagery from 4/6/11. Top Right: Post-event imagery from 3/19/12.  
Bottom: Post-event ground photos showing standing water and extent of damage

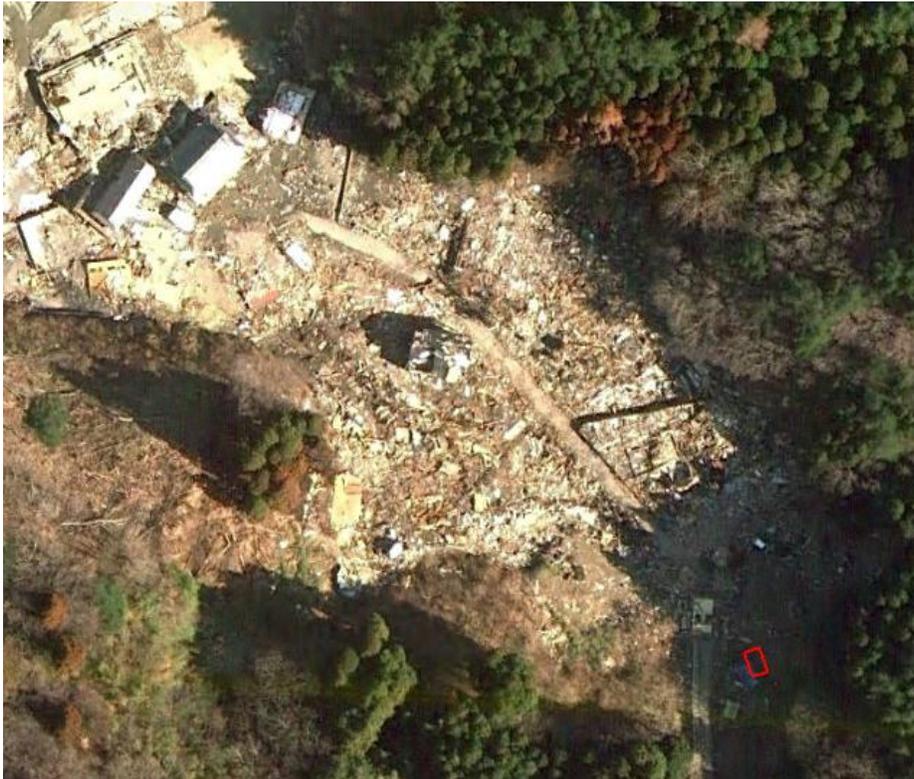
Satellite imagery showing the extent and degree of damage surrounding the facility.
