# HAZUS Tsunami Benchmarking, Validation and Calibration

**Ronald T. Eguchi  
Michael T. Eguchi  
Jawhar Bouabid  
Shunichi Koshimura  
William P. Graf**

**July 8, 2013**

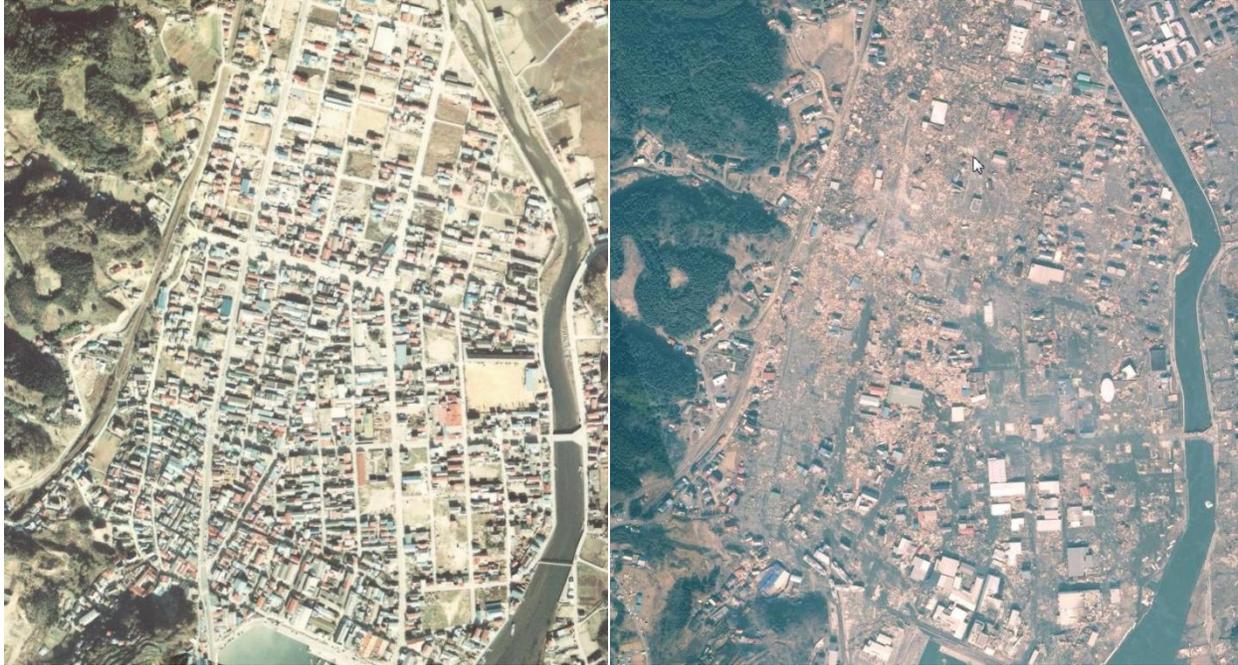
**Figure 8: Before (1977) and after Image (3/13/2011) of Northern Kesenuma**  
(Source: <http://saigai.gsi.go.jp/20110311eqBeforeAfter/html/015f.html>)

40% of these buildings experienced flow depths of 4 meters or higher. For Kesennuma, 19,815 buildings were contained in the Japanese database, with over 90% experiencing some level of damage. In fact, for Kesennuma, over 75% of the buildings suffered complete damage. Figure 8 shows a before and after image of an area located just north of Kesennuma port. The post-earthquake image to the right shows not only devastation to building stock but at least one bridge (located in the lower right-hand corner) has been washed away by the tsunami.

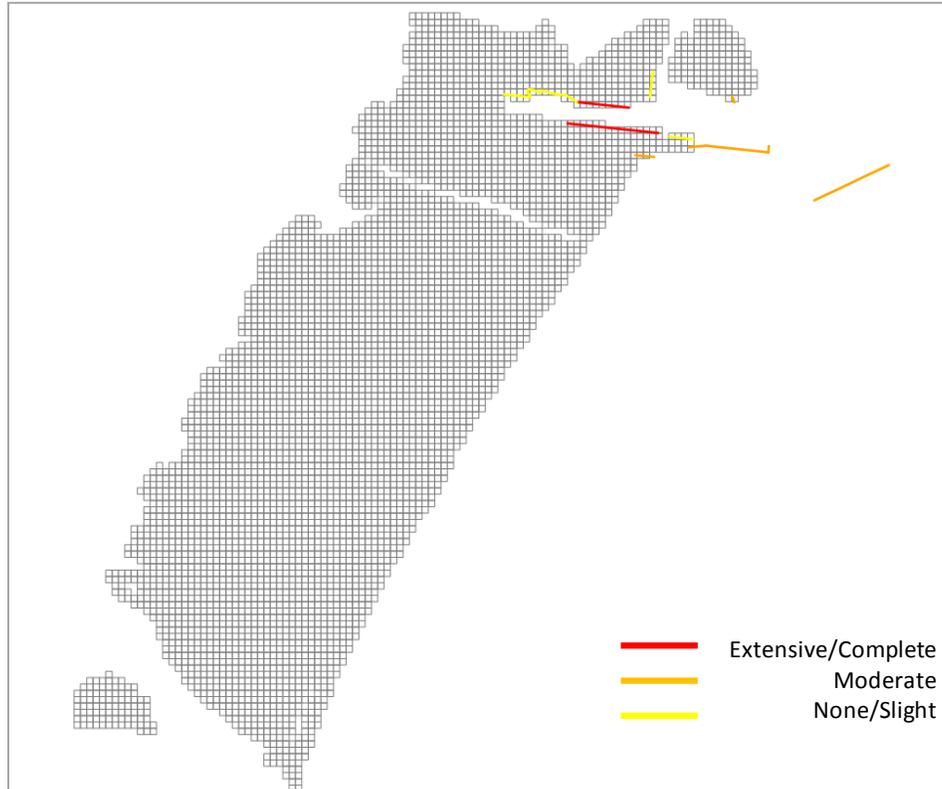
Figure 17: Delineation of Damage to Port Facilities in Sendai

Figure 17 shows recorded damage to port facilities in Sendai. Three damage states are noted in the figure: extensive/complete (red), moderate (orange) and none/slight (yellow). As noted earlier in Table 11, in order to properly match the Japanese-defined damage states to those used in HAZUS, the “Extensive” and “Complete” damage states (in HAZUS) were combined. Complete damage noted in the figure is associated with wharf facilities.

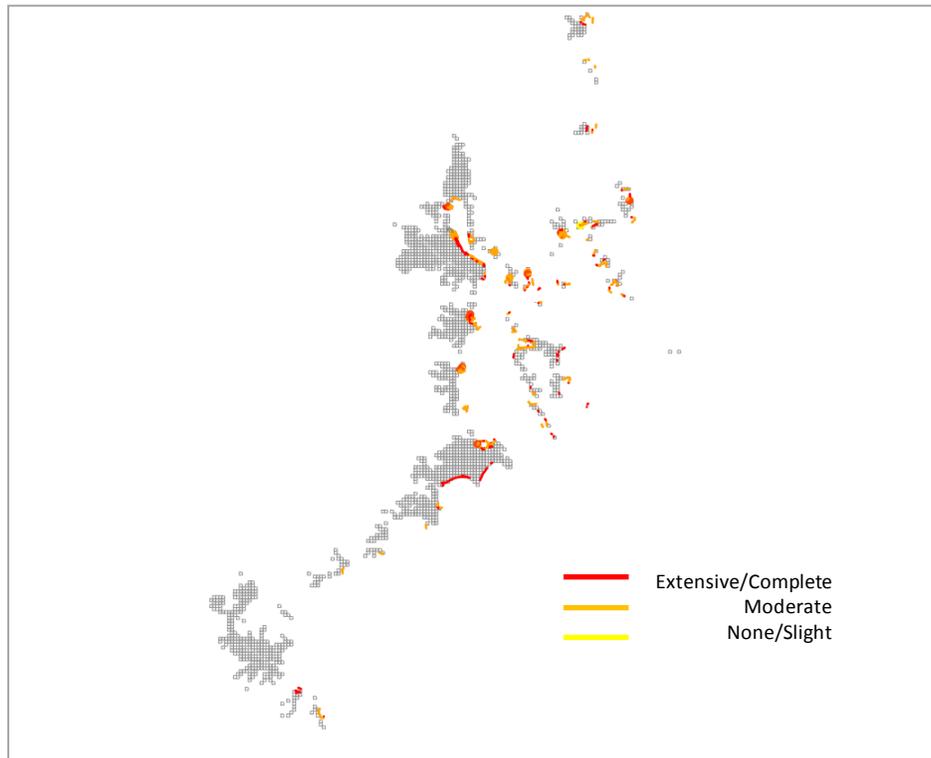
**Figure 18: Delineation of Damage to Port Facilities in Kesennuma**

Figure 18 provides a delineation of damage for port facilities in Kesenuma. Unlike Sendai, damage is spread through the region that surrounds the port of Kesenuma.

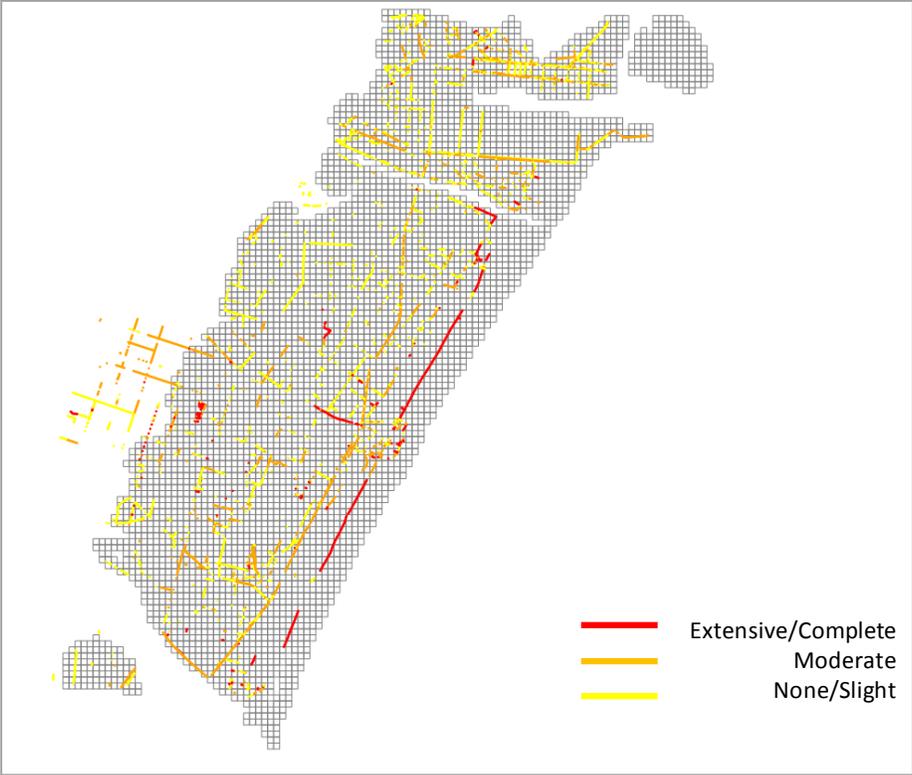
**Figure 19: Roadway Damage in Sendai**

Roadway damage in the two study regions is illustrated in Figures 19 and 20. Unsurprisingly, roadway damage is highest in areas closest to the coastline for both regions. Although roadways are assigned different damage states in the MLIT database, it is not entirely clear what type of effects or damage are associated with each state. A possible task following this study is to obtain clarification of from Japanese investigators on the damage criteria used to assign damage states to different roadway systems. Damage could be defined based on actual pavement damage from water undermining the soil beneath the pavement, or from debris that is deposited on the roadway from incoming tsunami waves. At this point, not enough detail is provided in the MLIT database to discern these different effects. Table 13 provides a high-level summary of roadway damage by damage class.

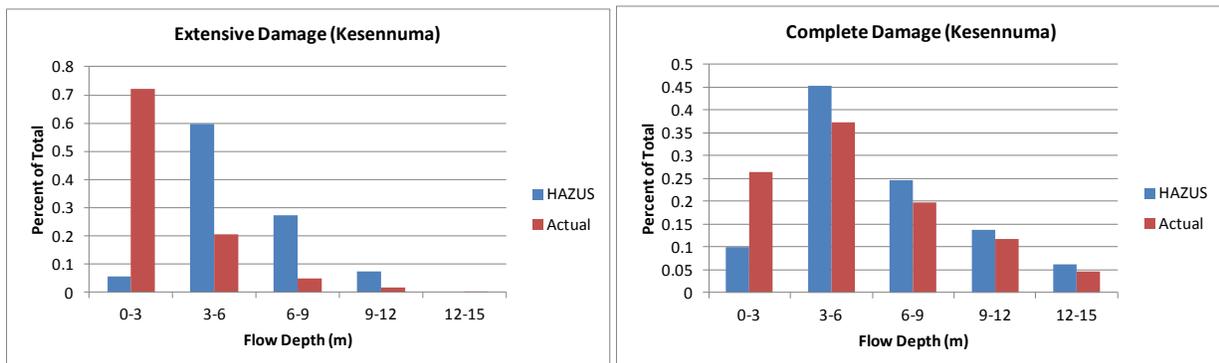
**Figure 23: Comparison of Predicted versus Actual Observations of Building Damage for Kesennuma**

Figure 23 provides a similar comparison between predicted versus actual observed building damage for Kesennuma. In this comparison, the median flow depth for extensive damage is significantly different from the HAZUS prediction producing a median flow depth of about 3 meters as compared to about 1 to 2 meters from the MLIT data. For complete damage, the median values of flow depth are more comparable with both around 3 to 6 meters.

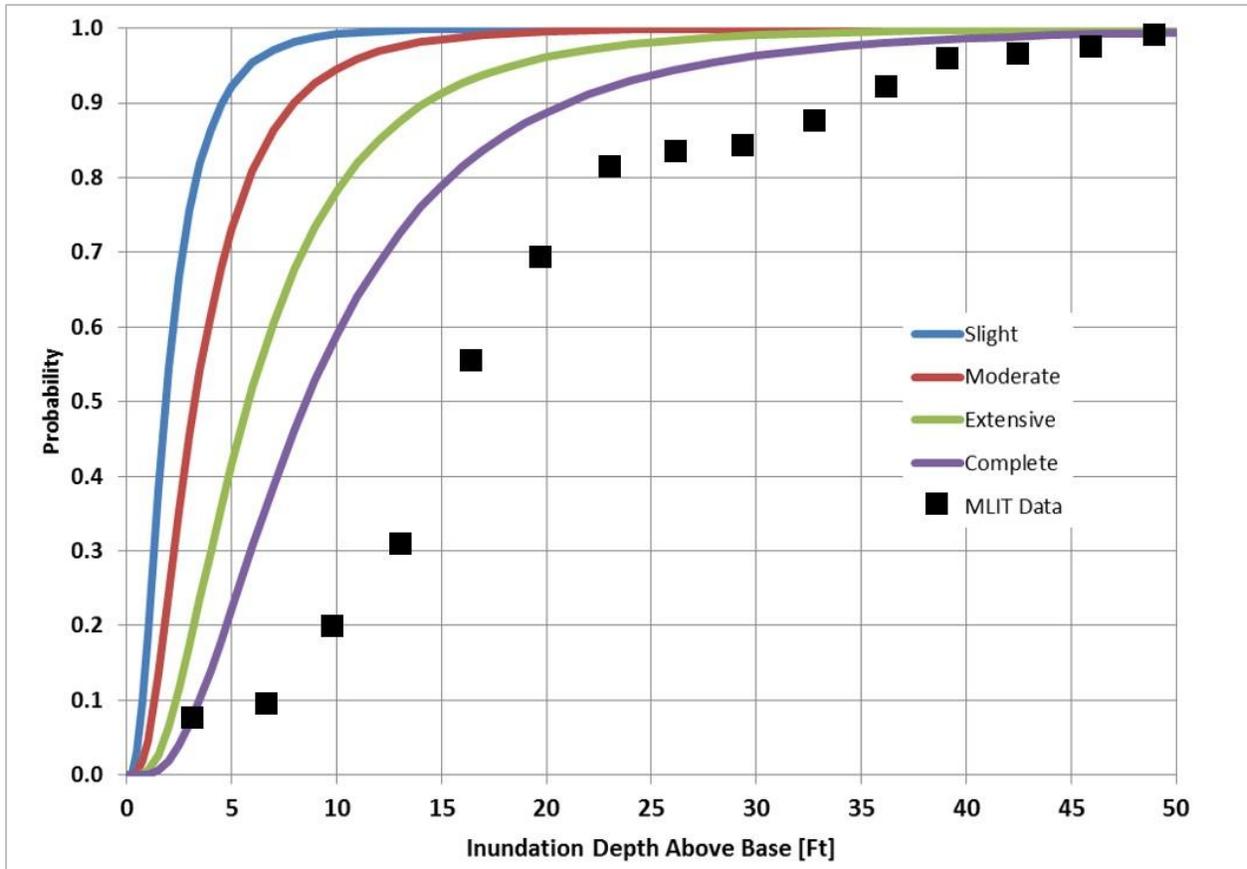
**Figure 24: A Comparison of HAZUS-generated fragilities with Actual Data from the Tohoku earthquake (Note: MLIT data points only for Extensive and Complete damage)**

In Figure 24, the MLIT data points suggests that the HAZUS fragility model using the parameters given above overestimates the probabilities of experiencing either complete or extensive damage, i.e., the MLIT data points are located to the right of the curves. There could be a variety of reasons why this is the case, however, without performing a thorough sensitivity analysis, it is difficult to identify which parameters or assumptions are responsible for the differences. We know that at best, these comparisons provide a starting point or a benchmark for scaling and that the initial models are the result of expert opinion and not empirical data. Therefore, it is no surprise that we see large differences between the curves and actual data.

In order to proceed with a calibration of the model, we strongly recommend that bridge performance data from other areas affected by the Tohoku earthquake (besides Sendai and Kesenuma) be added to the comparison dataset. In addition, to ensure that the damage totals are normalized to the entire set of bridges affected by inundation, we recommend that bridge inventory data for each study area be sought from the appropriate government agency. Although it is possible to identify bridges from remote sensing imagery (this is especially true for bridges crossing rivers or water bodies), it may be difficult to identify all bridges especially if there are small and/or located in densely built-up areas.

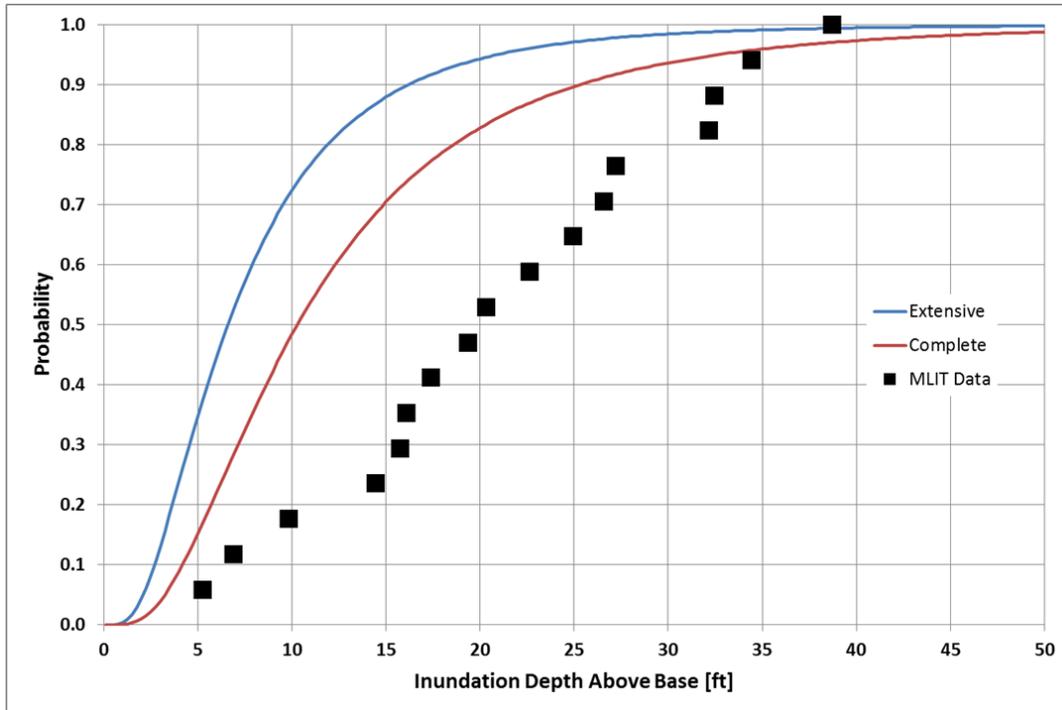
**Figure 25: Tsunami Fragility Curve for Sewage/Water Facilities (data points in figure are plots of Tohoku damage data)**

Figure 25 shows two fragility curves, one for “Extensive” damage and one for “Complete” damage. The curves are for sewage pump or lift stations. In order to increase the size of the data sample for these comparisons, the project team decided to combine MLIT damage data for sewage and water pump stations, and water and sewage treatment facilities. The project team felt that the type of construction for all of these facilities would be roughly the same (i.e., reinforced-concrete, block buildings, low story) and the type of equipment in these facilities would also be similar (e.g., pumps, pipes, generators, electrical equipment). Appendix A contains aerial and ground photos for all facilities listed in Table 12. In total, 17 sewage/water facilities were included in the comparison. The empirical fragility data are plotted along side of the two HAZUS fragility curves.

A comparison shows that the match between the fragility model output and the MLIT data does not result in a good match. The project team has speculated why this may be the case. One of the obvious possibilities is that the flow or inundation depth associated with each facility may not have been the depth at which extensive or complete damage first began. That is, by plotting the MLIT damage data at the maximum flow depths measured we may be “pushing” the empirical data out too far. In order to investigate this, we have plotted a second set of MLIT data points where we only include damage data with flow depths less than 25 feet (a typical story height for a pump station – see Appendix A). The comparison, shown in Figure 26 shows that the empirical data is roughly in the same probability/flow depth range as the fragility curves for “Extensive” and “Complete” damage but suggests a linear versus exponential trend. It is difficult to conclude which trend or functional form is correct given the limited data sample. We suggest as part of a future study to include damage data from other cities in Japan in order to generate a more robust and perhaps more component-specific dataset for comparison.

Unfortunately, the MLIT data for other lifeline components is very limited and performing any comparisons are likely not to provide useful information to either validate or calibrate the existing fragility functions. We therefore strongly suggest that the damage data from other regions of Japan, which also greatly were affected by the tsunami, be included in more comprehensive analysis of lifeline fragilities.

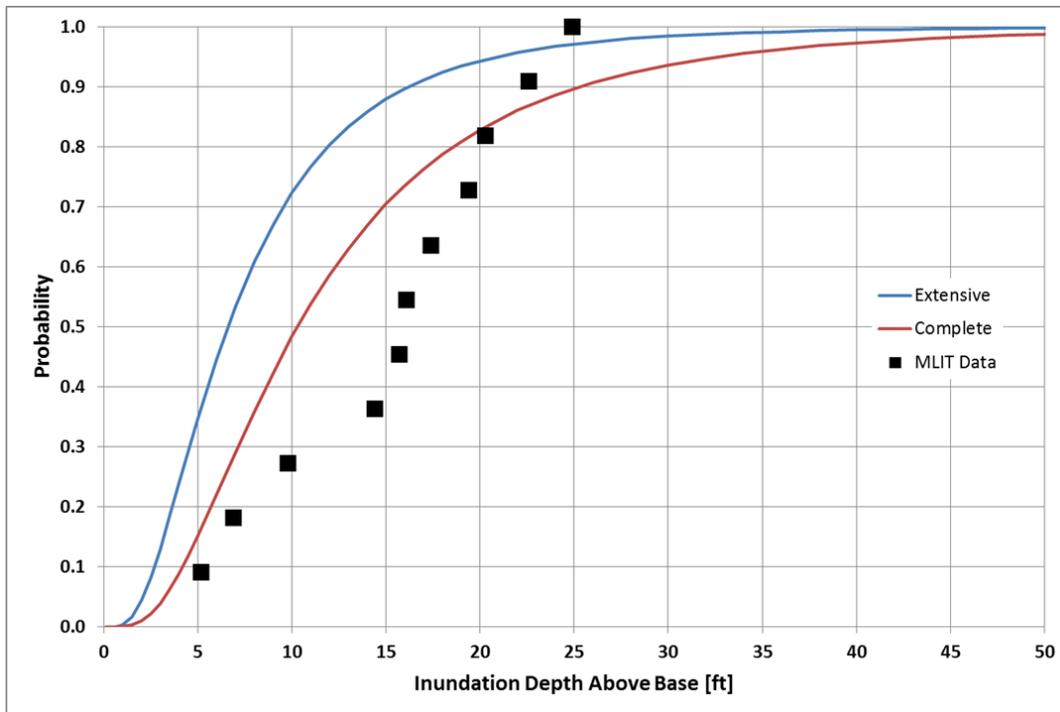
**Figure 26: Modified Tsunami Fragility Curve for Sewage/Water Facilities with only MLIT Damage Data having Flow Depths of 25 feet or lower.**

Another assumption that will need to be addressed is whether the data contained in Table 12 is a summary of all the lifeline facilities that were inundated in Sendai and Kesenuma. If Table 12 only includes facilities that recorded some level of damage, then the damage rates that are presented in Figures 25 and 26 would have to be adjusted, i.e., normalized by the total number of facilities experiencing that flow depth. This would further increase the differences between the HAZUS modeled results and the actual MLIT damage data.

As with the bridge results, the research team strongly suggests that the damage data be augmented with data from other affected regions and that a systematic and thorough calibration of the models be conducted on the larger dataset. In addition, with larger datasets it may be possible to refine the categories of lifeline components and produce individual fragility models for each lifeline system.

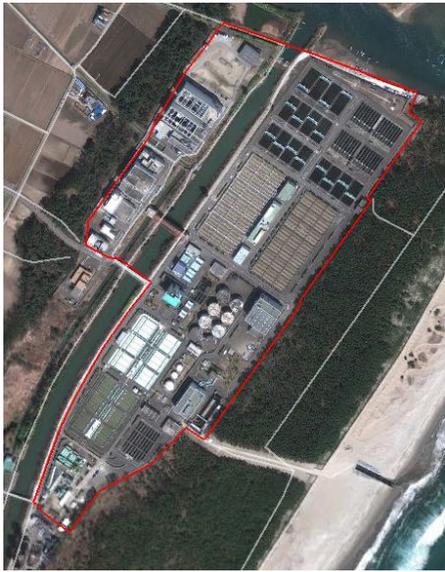
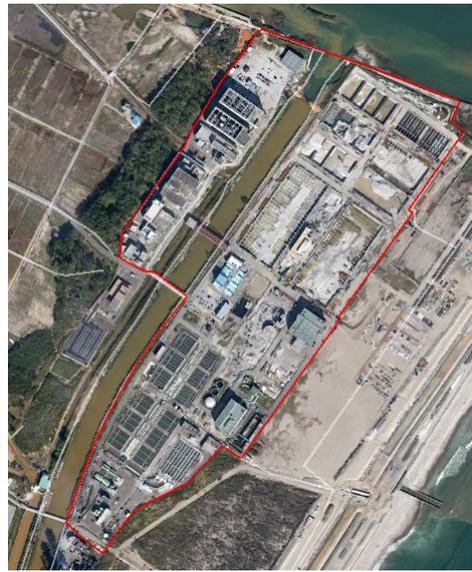
**Damage Level (HAZUS Visual):** Complete

**Comments:** Most structures still standing immediately following the event (imagery date 4/6/11), however, demolition of a few building and all tanks is apparent in imagery from 8/19/12.

Top Left: Pre-event imagery from 4/4/11. Top Right: Post-event imagery from 8/19/12),  
Bottom: Zoomed in view of post-event imagery showing demolition in process

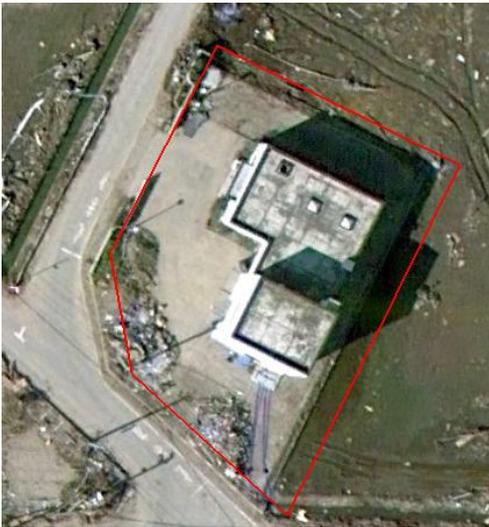
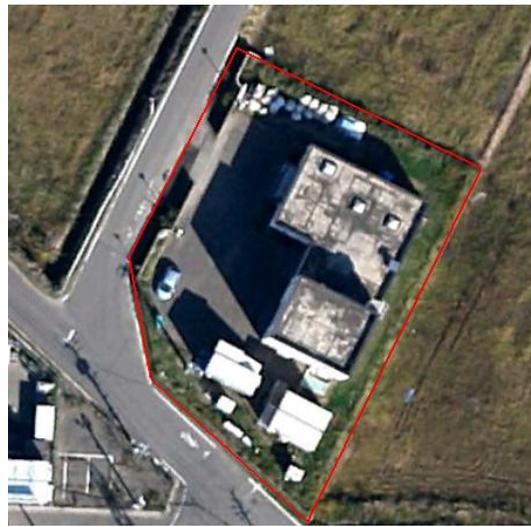
**Damage Level (HAZUS Visual):** Moderate

**Comments:** No heavy damage visible immediately following the tsunami. No sign of demolition. Appears skylight has been repaired and cars are in the lot suggesting building is functional (or soon to be).

Top Left: Post-event imagery from 4/6/11. Top Right: Post-event imagery from 8/19/12.  
Bottom: Ground photo of facility (No heavy damage visible).

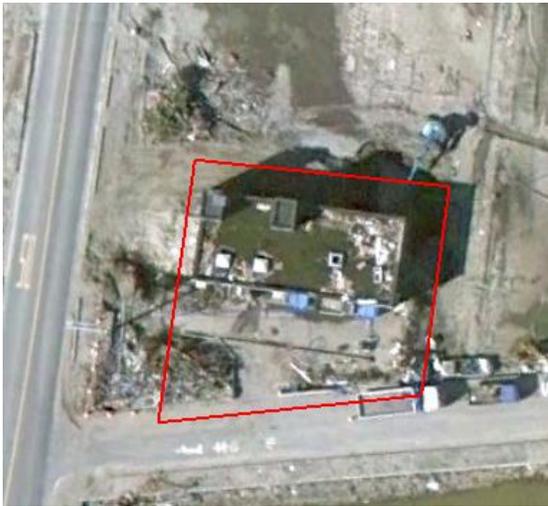
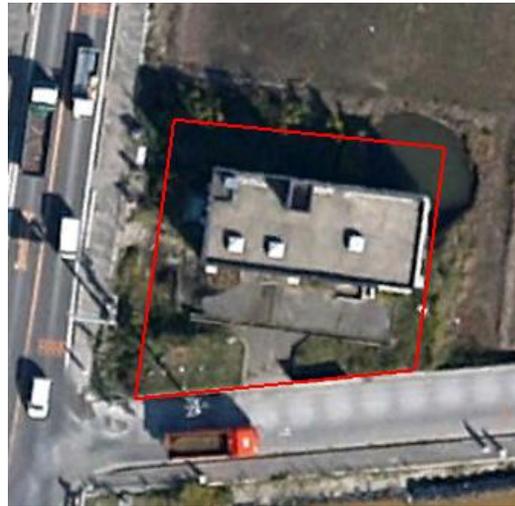
**Damage Level (HAZUS Visual):** Moderate

**Comments:** Heavy damage following the tsunami, however it appears the structure has been repaired with no evidence of a demolition.

Top Left: Post-event imagery from 4/6/11. Top Right: Post-event imagery from 8/19/12.  
Bottom: Ground photo of facility (No heavy damage visible).

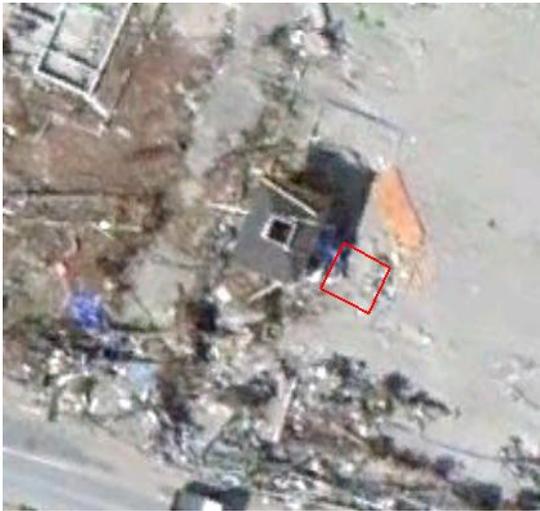
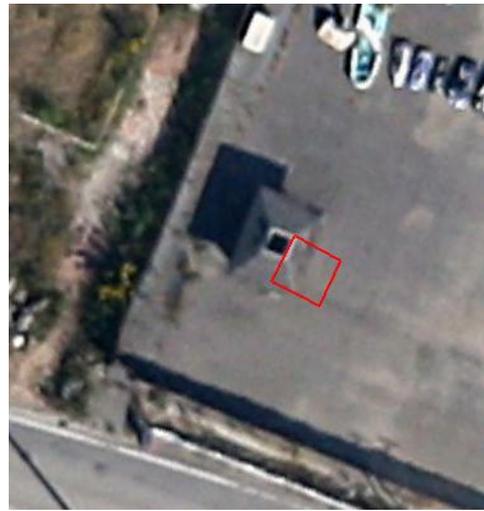
**Damage Level (HAZUS Visual):** Moderate

**Comments:** Heavy debris surrounding the structure. It appears repairs have been made from post-event imagery and ground photos.

Top Left: Post-event imagery from 4/6/11. Top Right: Post-event imagery from 8/19/12.

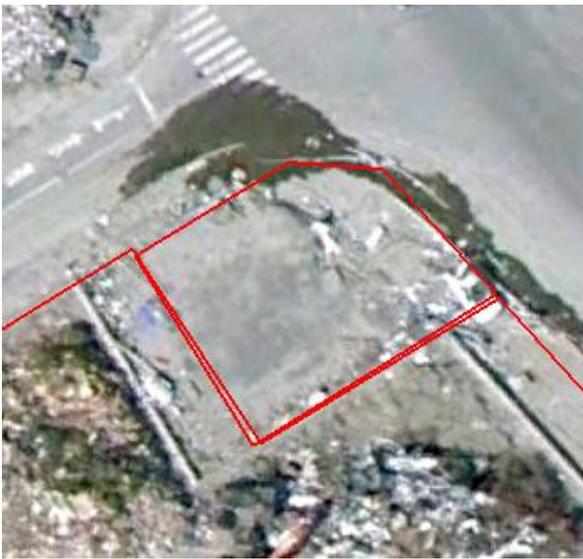
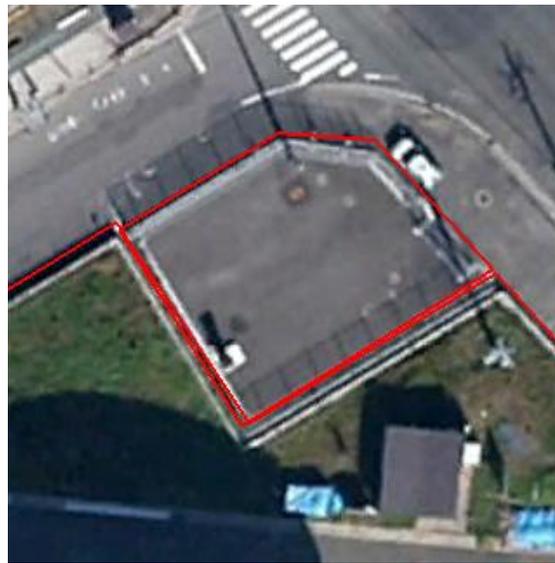
**Damage Level (HAZUS Visual):** Complete

**Comments:** Collapse based on post-event imagery (4/6/11) and ground photos (only the foundation remains). It has since been rebuilt, based on imagery from 8/9/12.

Top Left: Post-event imagery from 4/6/11. Top Right: Post-event imagery from 8/19/12.

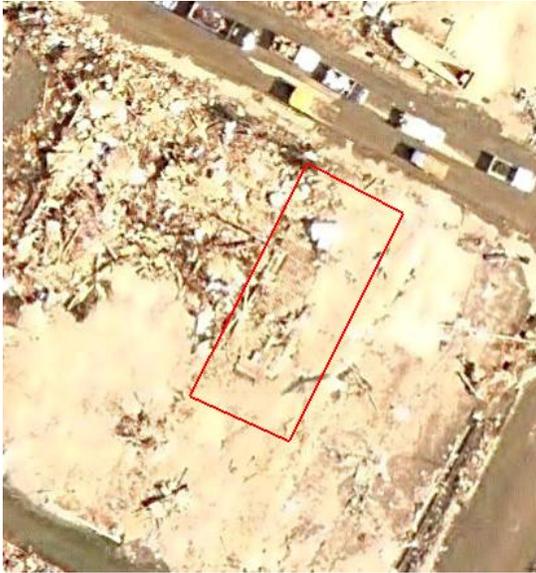
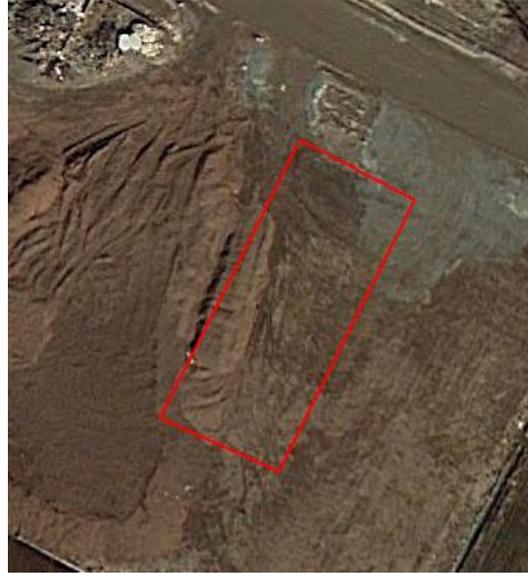
**Damage Level (HAZUS Visual):** Complete

**Comments:** The subject facility (and all surrounding) was washed away.

Left: Post-event imagery from 4/6/11. Right: Post-event imagery from 8/19/12.

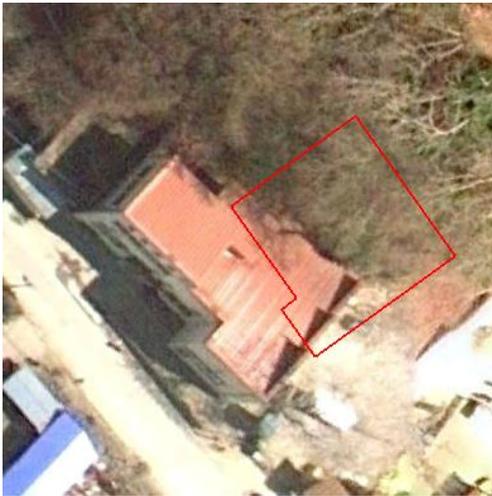
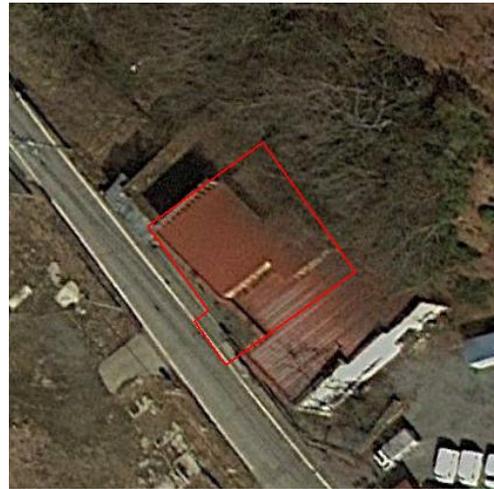
**Damage Level (HAZUS Visual):** Moderate

**Comments:** No major damage visible immediately following the event. Structure appears to have been repaired (glass windows and doors not broken).

Top Left: Post-event imagery from 4/6/11. Top Right: Post-event imagery from 8/19/12.  
Bottom: Ground photo of facility (no significant damage visible)

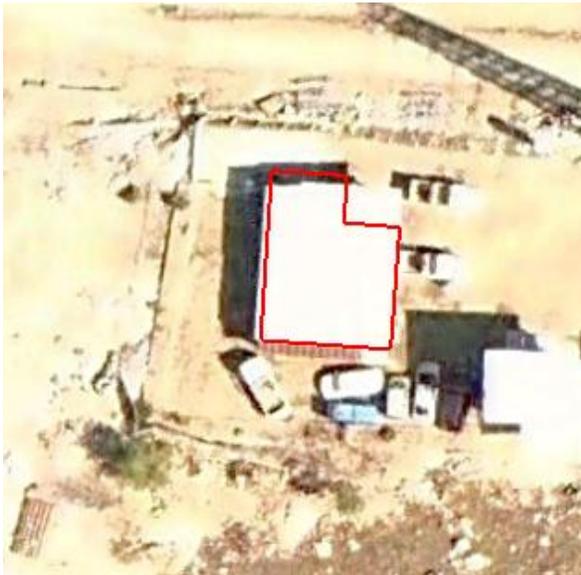
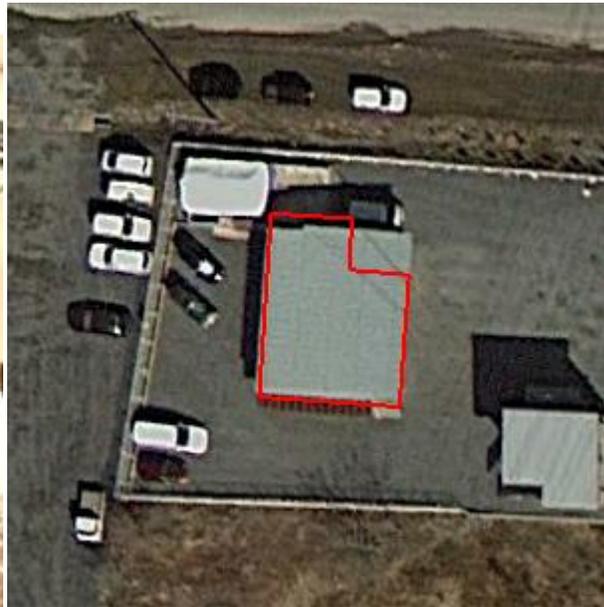
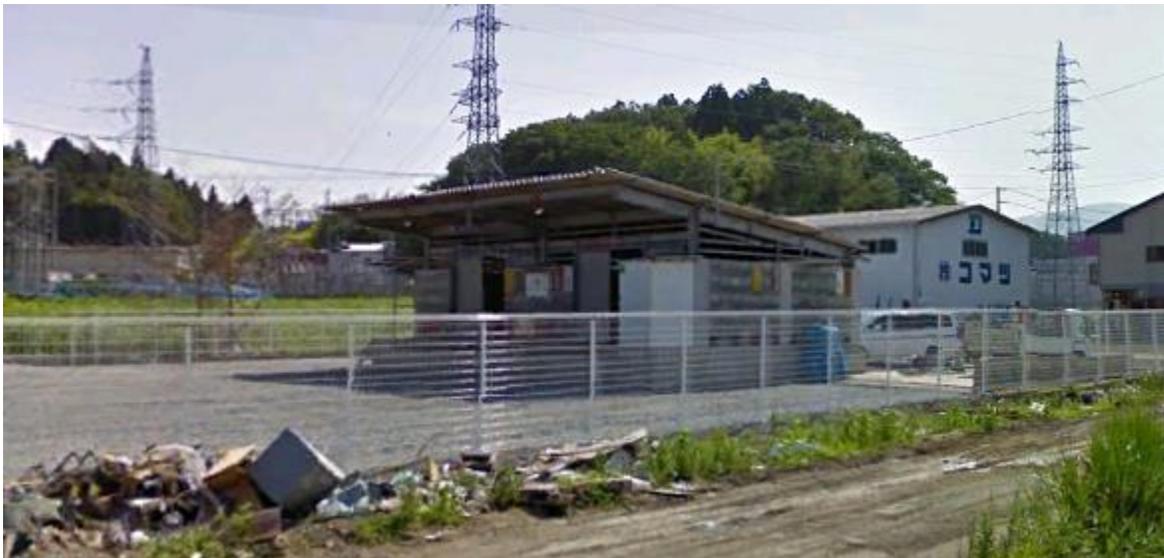
**Damage Level (HAZUS Visual):** Moderate

**Comments:** The structure shows no evidence of catastrophic damage or demolition and reconstruction from satellite imagery ranging from 4/6/11 to 3/19/12.

Top Left: Post-event imagery from 4/6/11. Top Right: Post-event imagery from 3/19/12.

Bottom: Post-event ground photo showing no major damage to the facility

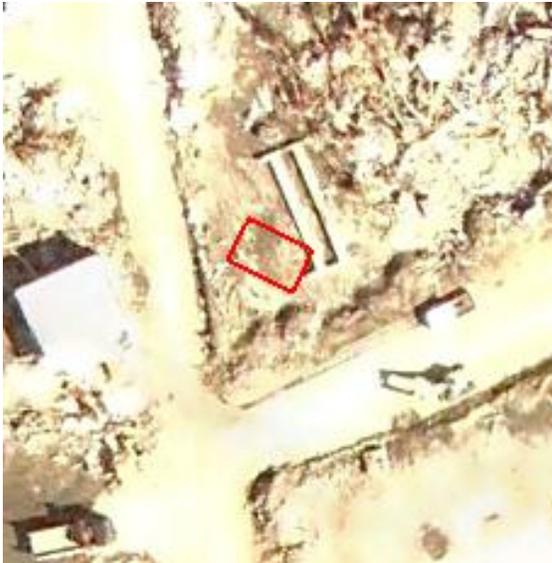
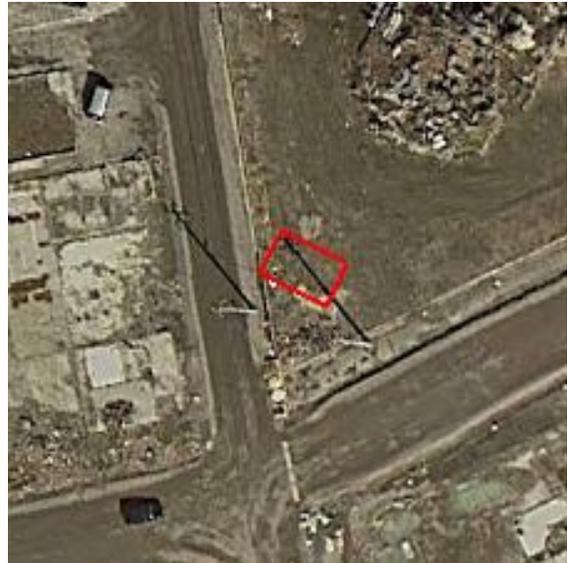
**Damage Level (HAZUS Visual):** Complete

**Comments:** The component and surrounding structures have completely been washed away.

Left: Post-event imagery from 4/6/11 showing washed away facility. Right: Post-event imagery from 3/19/12.

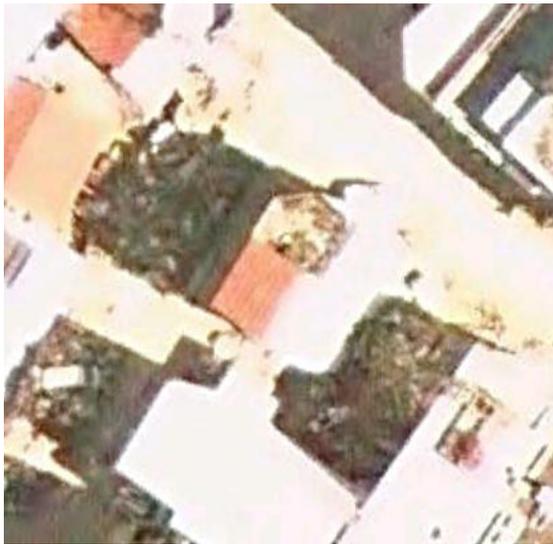
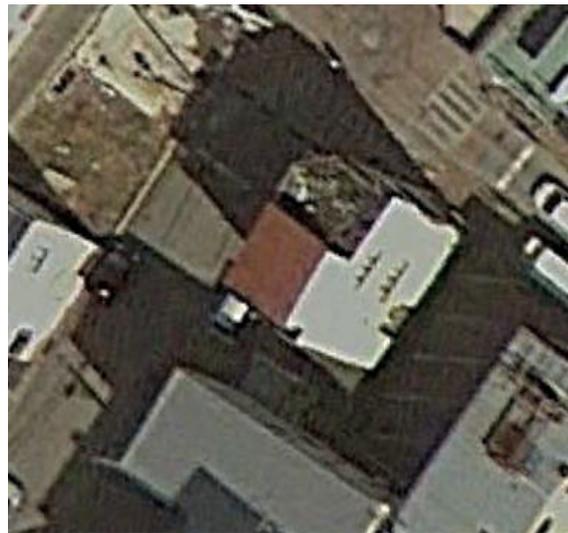
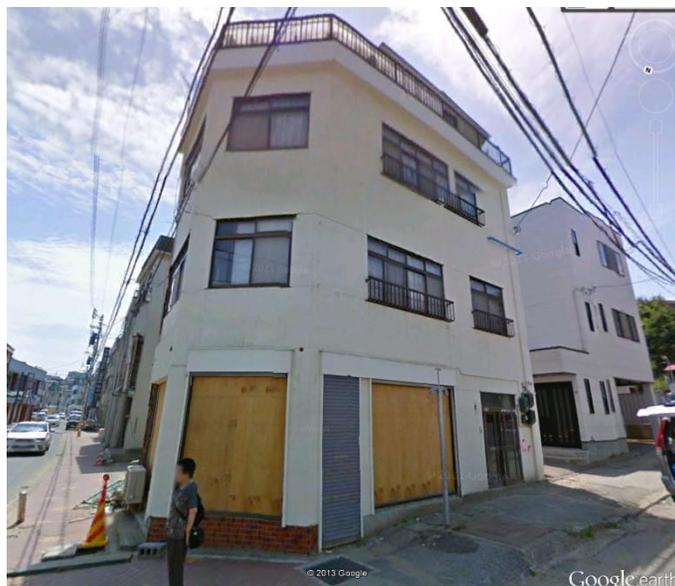
**Damage Level (HAZUS Visual):** Moderate

**Comments:** The structure is showing some signs of damage (surrounding debris, damaged roof, etc.) however appears to be salvageable based on ground photos and it's existence in post-event imagery from 3/9/12.

Top Left: Post-event imagery from 4/6/11. Top Right: Post-event imagery from 3/19/12.  
Bottom: Post-event ground photo showing no catastrophic damage to the facility

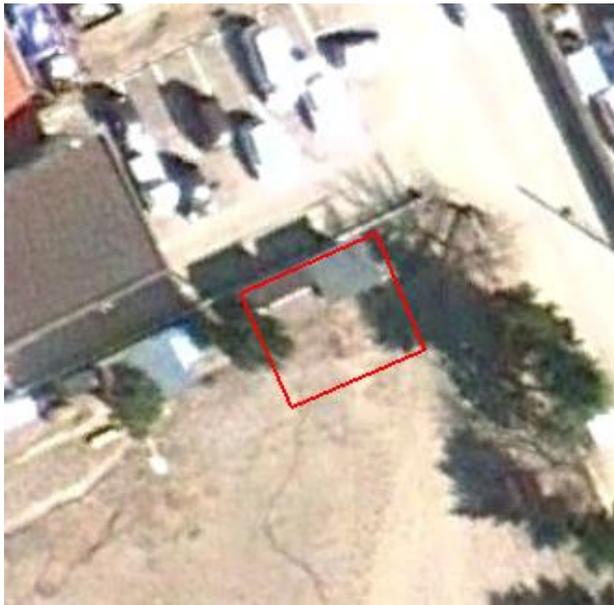
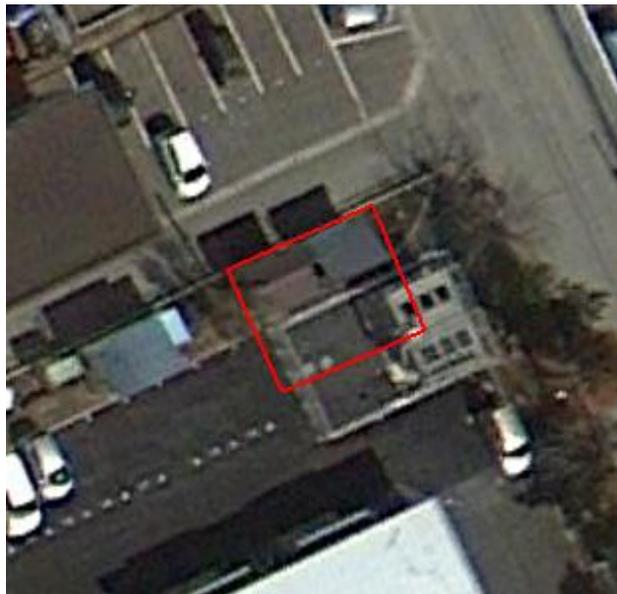
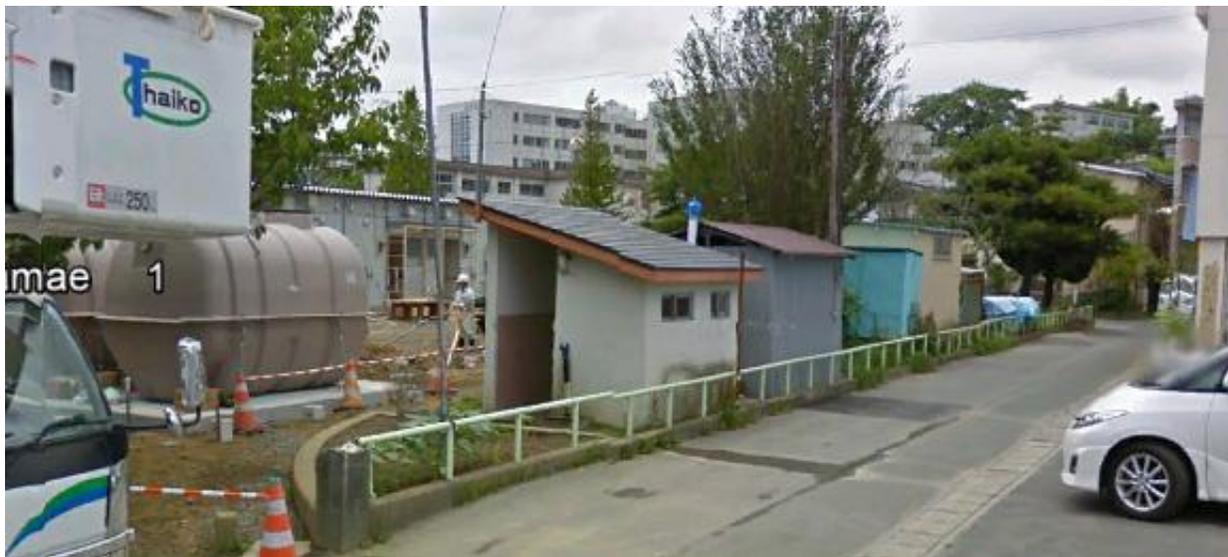
**Damage Level (HAZUS Visual):** Moderate

**Comments:** No major damage visible. No observable change between satellite images. The structure was only subject to 0.6m of water, however not enough evidence is available to downgrade the damage to slight.

Top Left: Post-event imagery from 4/6/11. Top Right: Post-event imagery from 3/19/12.

Bottom: Post-event ground photo showing no major damage to the facility

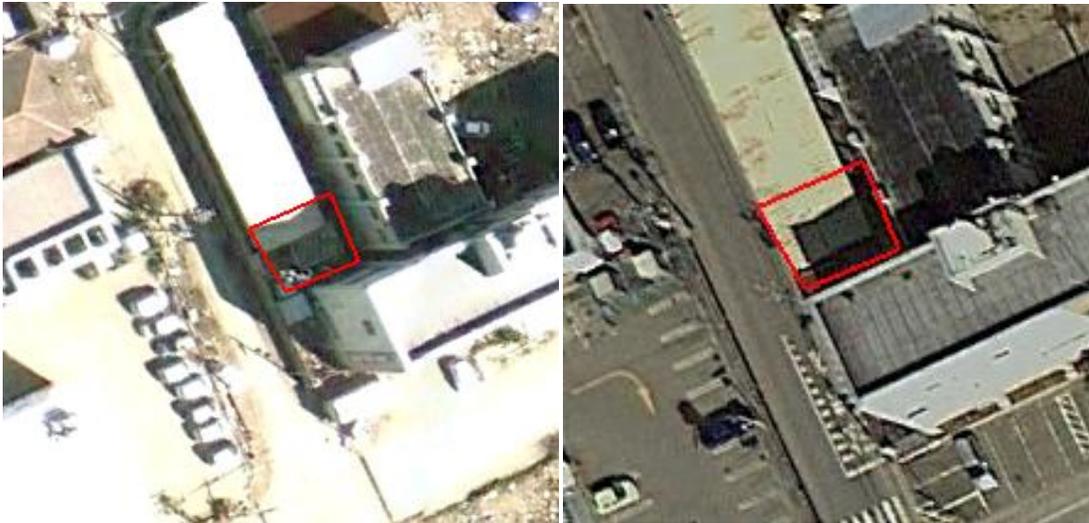
**Damage Level (HAZUS Visual):** Moderate

**Comments:** No major damage visible. No observable change between satellite images.

Left: Post-event imagery from 4/6/11. Right: Post-event imagery from 3/19/12 (no observable changes).

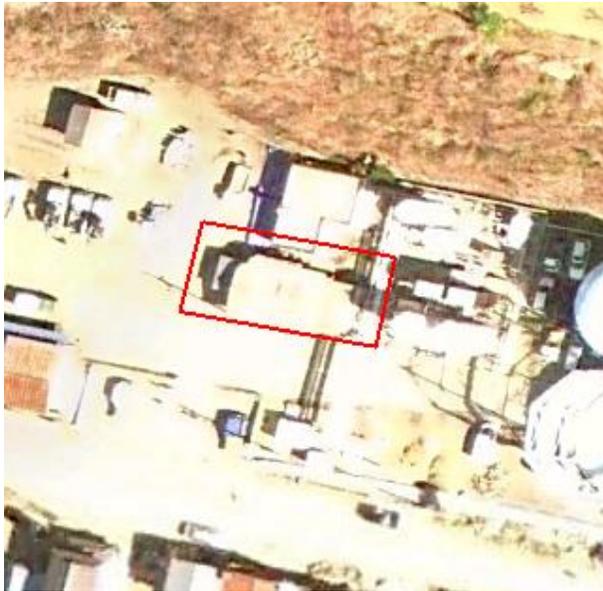
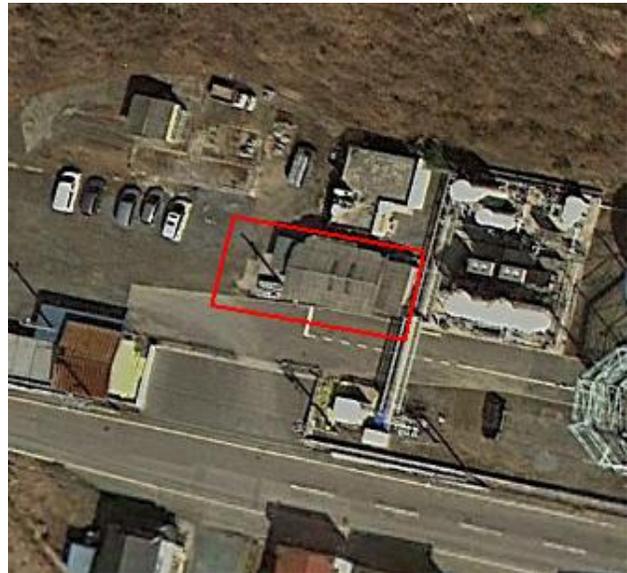
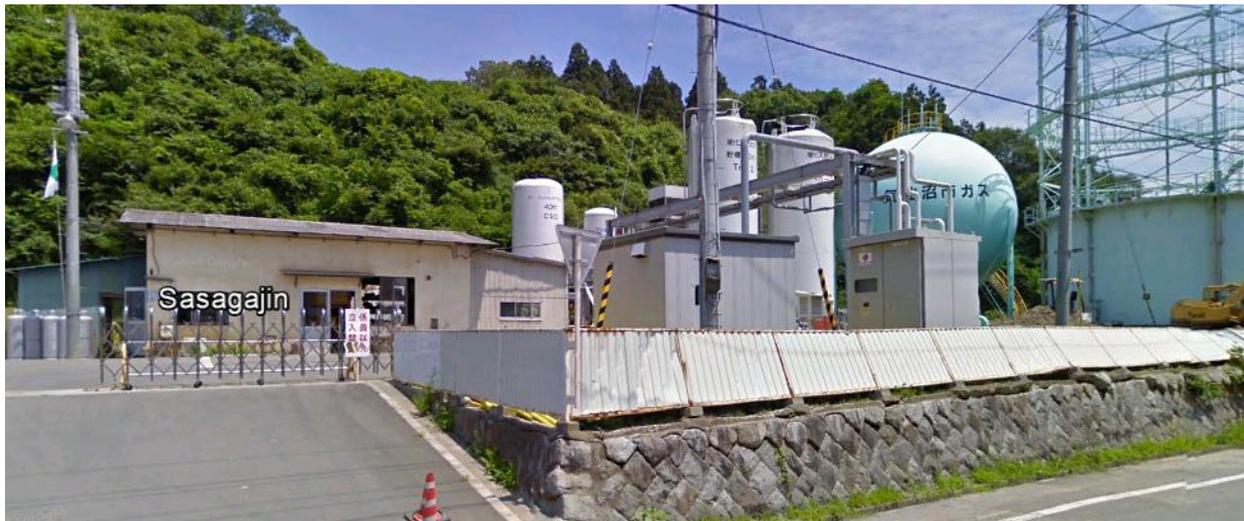
**Damage Level (HAZUS Visual):** Moderate

**Comments:** No major damage visible. No observable change between satellite images.

Top Left: Post-event imagery from 4/6/11. Top Right: Post-event imagery from 3/19/12.

Bottom: Post-event ground photo showing no major damage to the facility

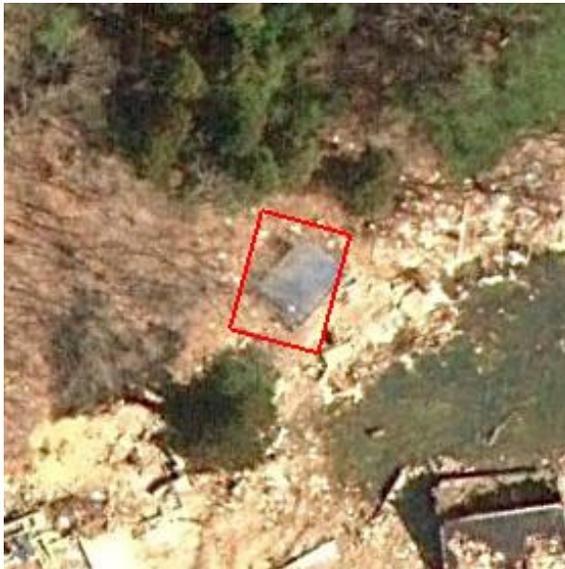
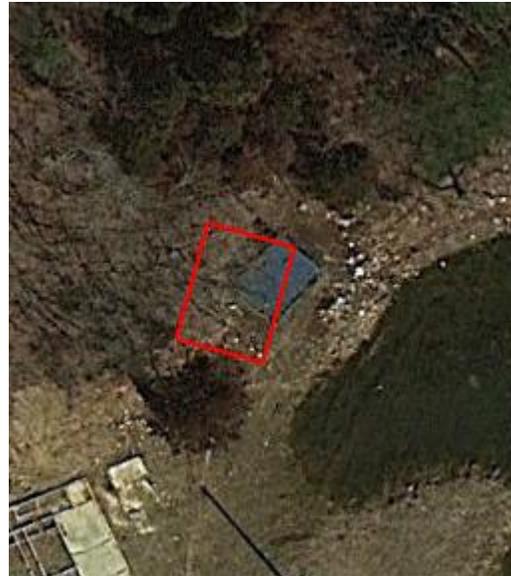
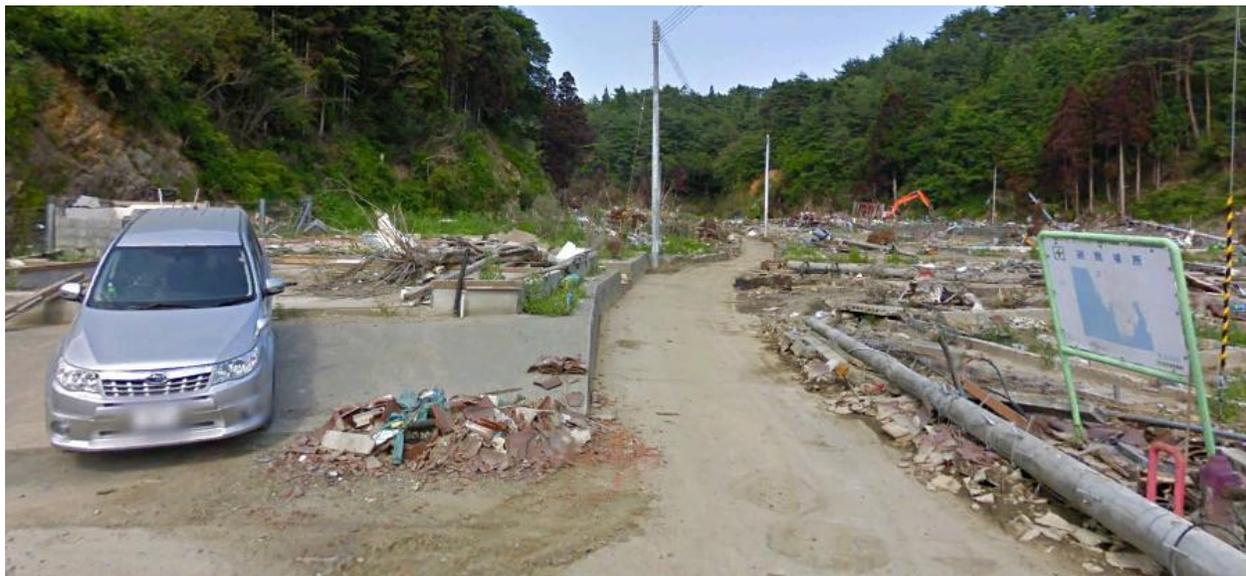
**Damage Level (HAZUS Visual):** Complete

**Comments:** Large amounts of debris in the area. All surrounding structures have been washed away.

Top Left: Post-event imagery from 4/6/11. Top Right: Post-event imagery from 3/19/12.

Bottom: Post-event ground photo showing area completely washed away.

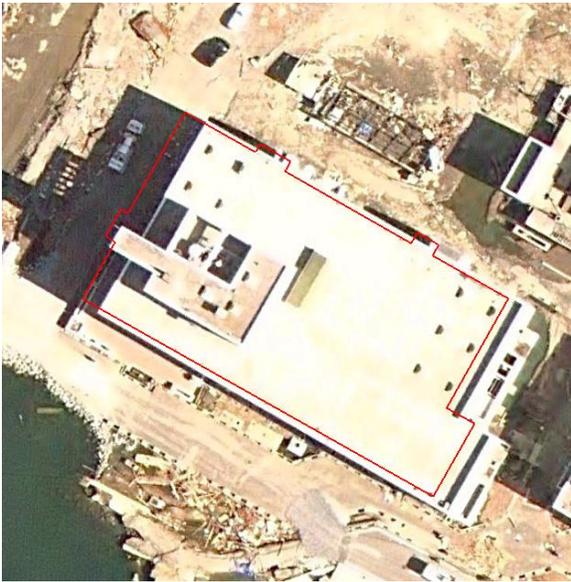
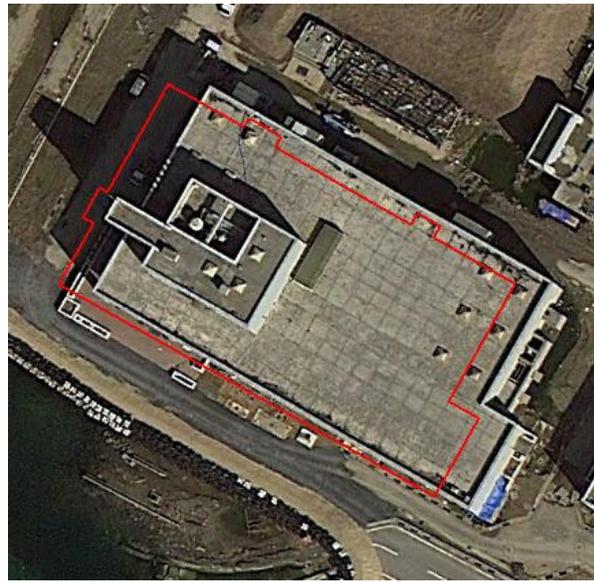
**Comments:** No catastrophic damage evident in imagery from 4/6/11. Debris surrounding has been cleaned up. No evidence of demolition.

Top Left: Post-event imagery from 4/6/11. Top Right: Post-event imagery from 3/19/12 showing no obvious repairs  
Bottom: Post-event ground photos showing extent of damage
