# HAZUS Tsunami Benchmarking, Validation and Calibration

**Ronald T. Eguchi  
Michael T. Eguchi  
Jawhar Bouabid  
Shunichi Koshimura  
William P. Graf**

**July 8, 2013**

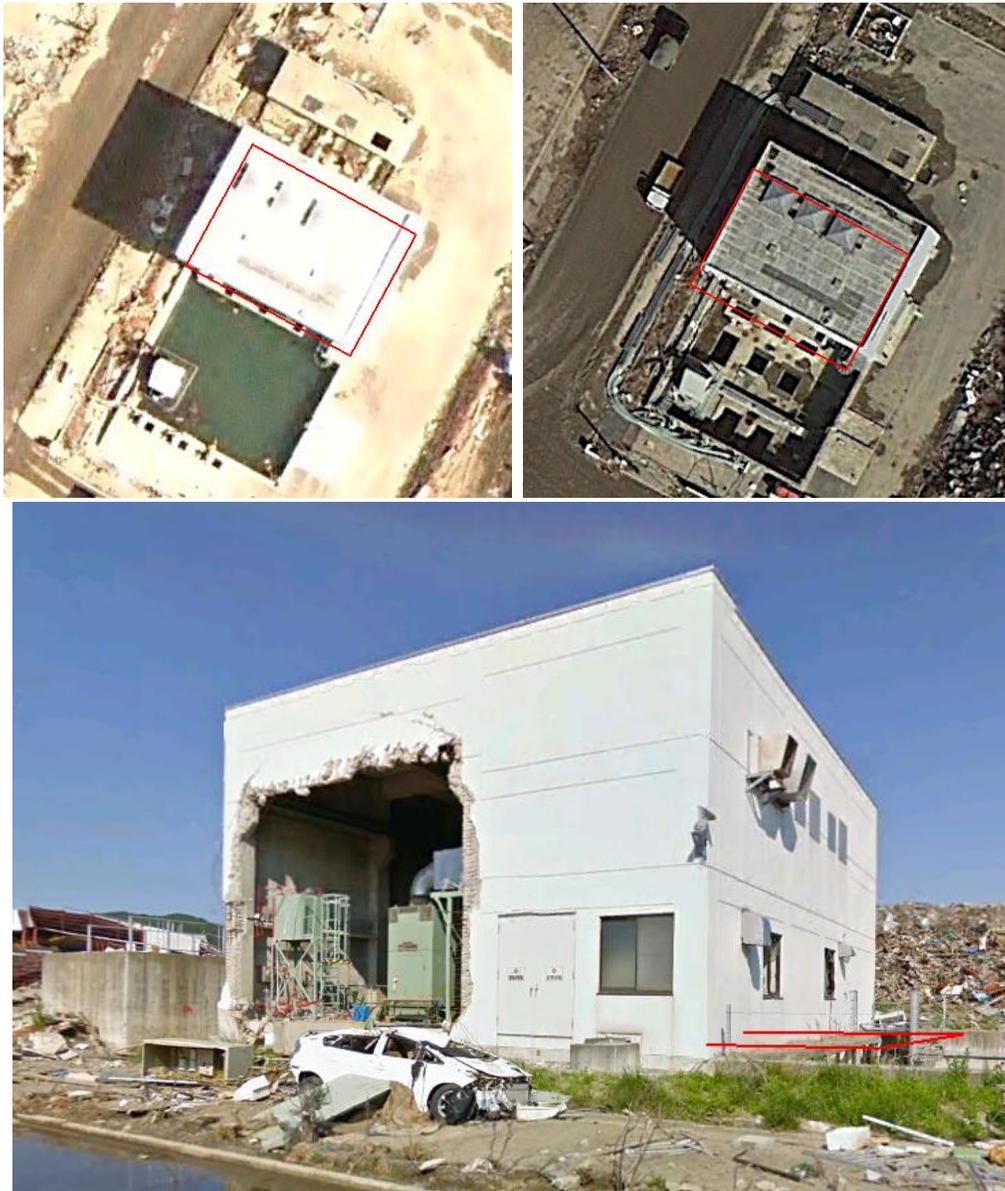
**Comments:** Satellite imagery shows little damage to the structure. Ground photos show a large hole in one side of the exterior wall. A more appropriate damage state would be extensive.

Top Left: Post-event imagery from 4/6/11. Top Right: Post-event imagery from 3/19/12.

Bottom: Post-event ground photos showing extent of damage

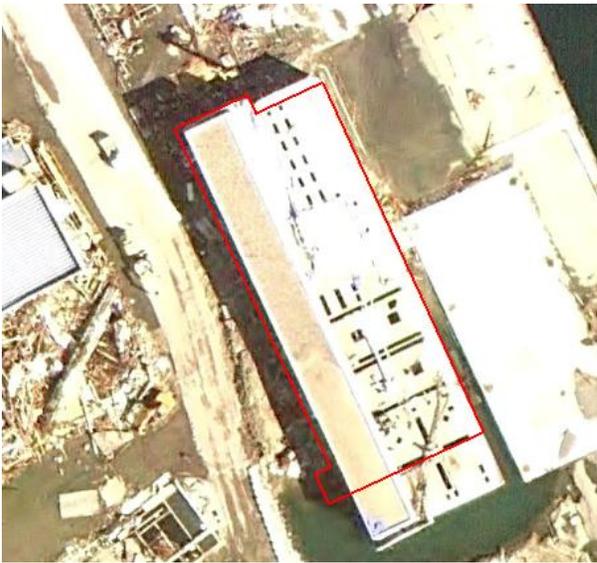
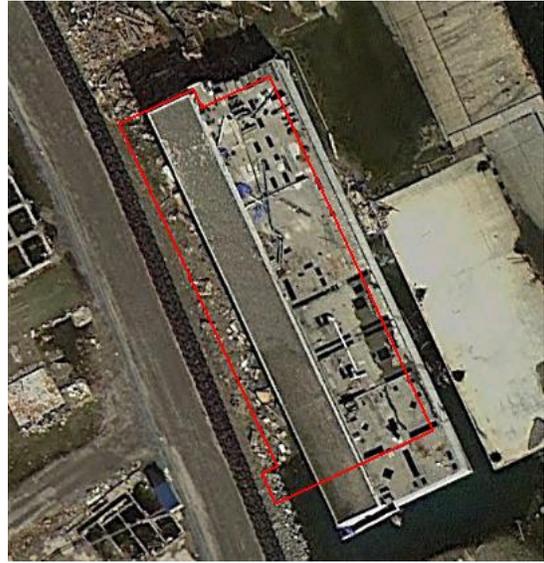
**Comments:** Surrounding structures have been destroyed. Debris and standing water are still present in satellite imagery from 3/19/12, suggesting repair is not intended.

Top Left: Post-event imagery from 4/6/11. Top Right: Post-event imagery from 3/19/12.  
Bottom: Post-event ground photos showing standing water and extent of damage

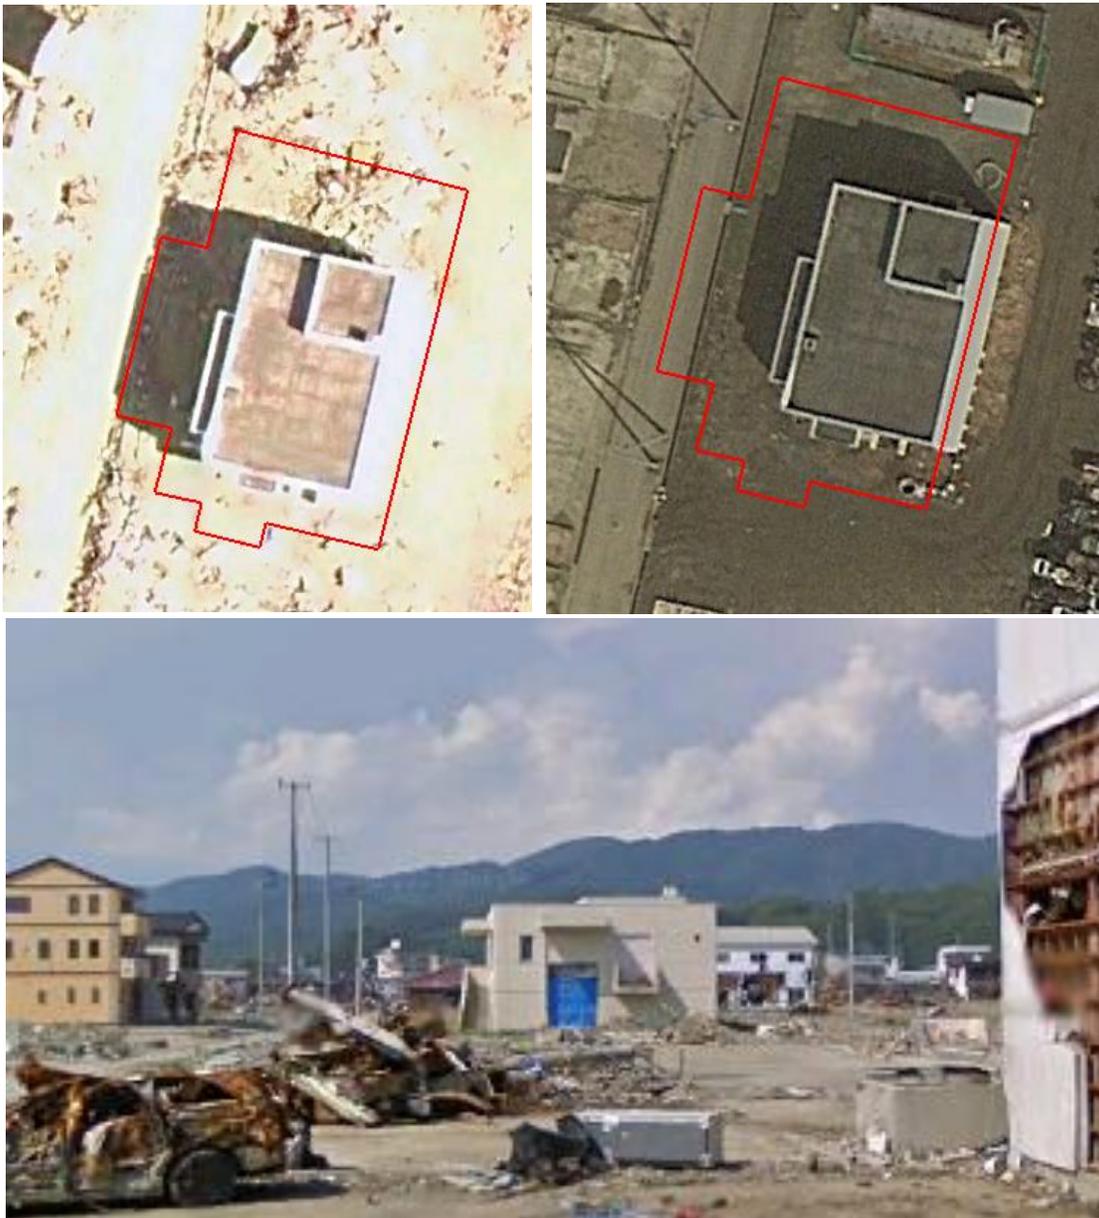
**Comments:** The surrounding structure has been cleaned up as evident in imagery from 3/19/12. No signs of a demolition are present, suggesting the building will be (or has been) repaired for use.

Top Left: Post-event imagery from 4/6/11. Top Right: Post-event imagery from 3/19/12.

Bottom: Post-event ground photos showing surviving structure.

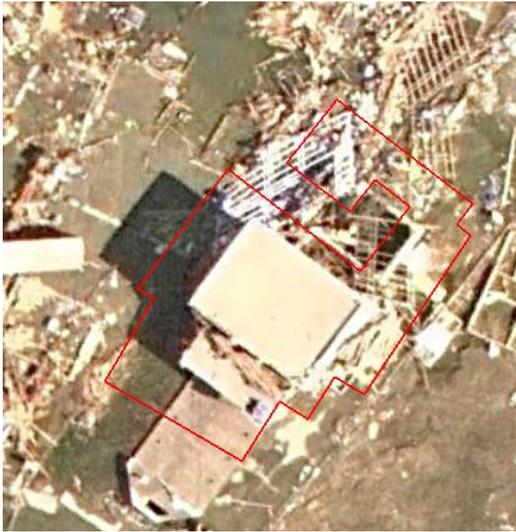
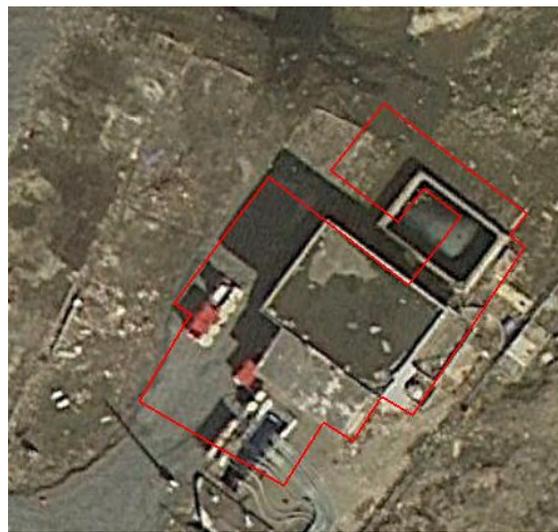
**Comments:** Large amounts of debris surrounding the structure in post-event imagery from 4/6/11. Heavy roof damage and damage from debris is evident. The area has been cleaned up and the structure has not been demolished as of 3/19/12 based on satellite imagery.

Left: Post-event imagery from 4/6/11. Right: Post-event imagery from 3/19/12 showing clean-up.

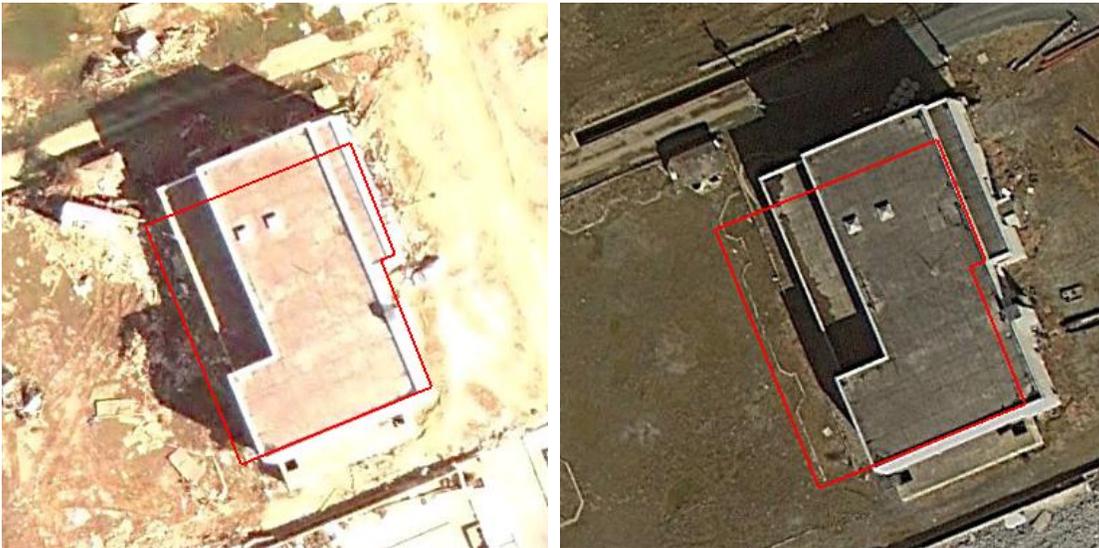
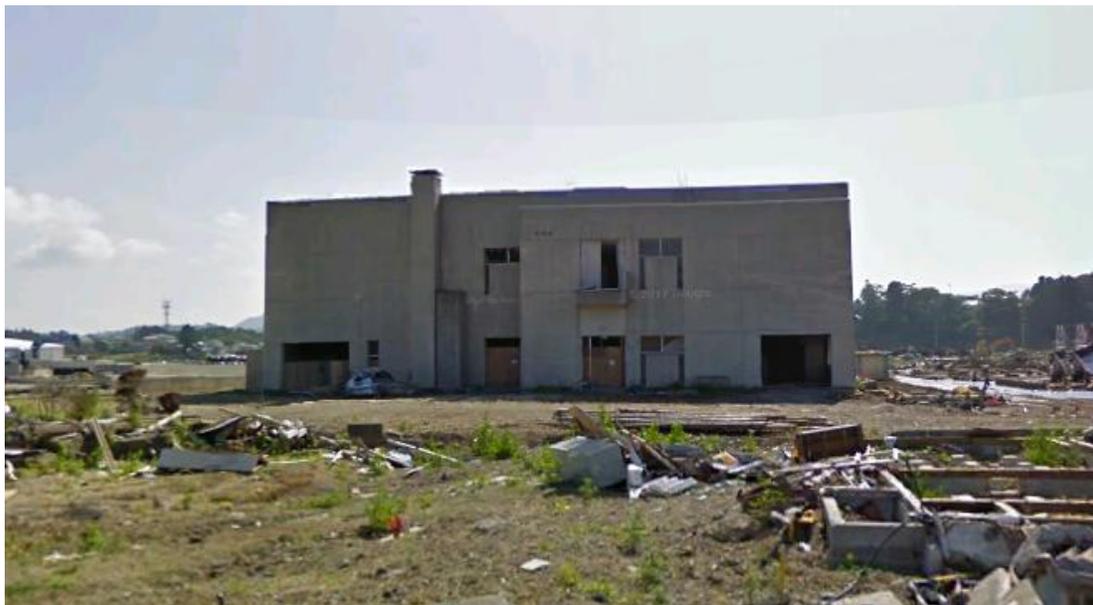
**Comments:** It is the only structure that survived around the area. Imagery 1 year after the event shows cleanup around building has occurred (no sign of demolition)

Top Left: Post-event imagery from 4/6/11. Top Right: Post-event imagery from 3/19/12.

Bottom: Post-event ground photos showing extent of damage.

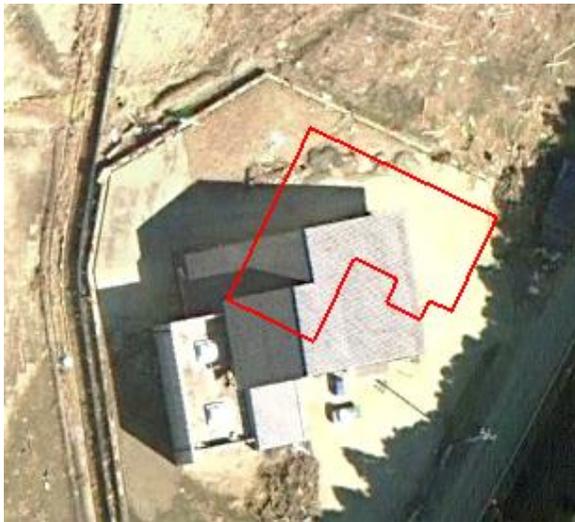
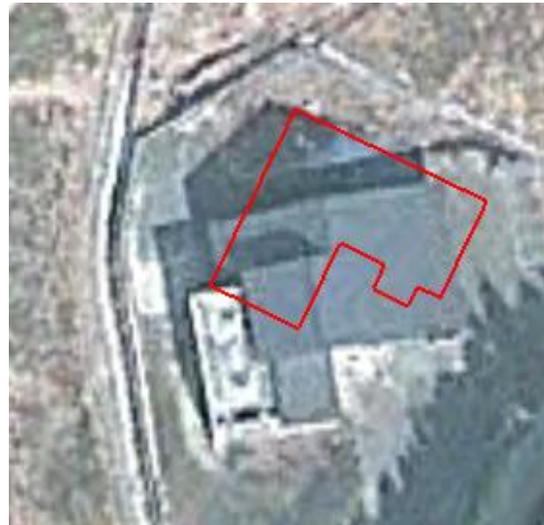
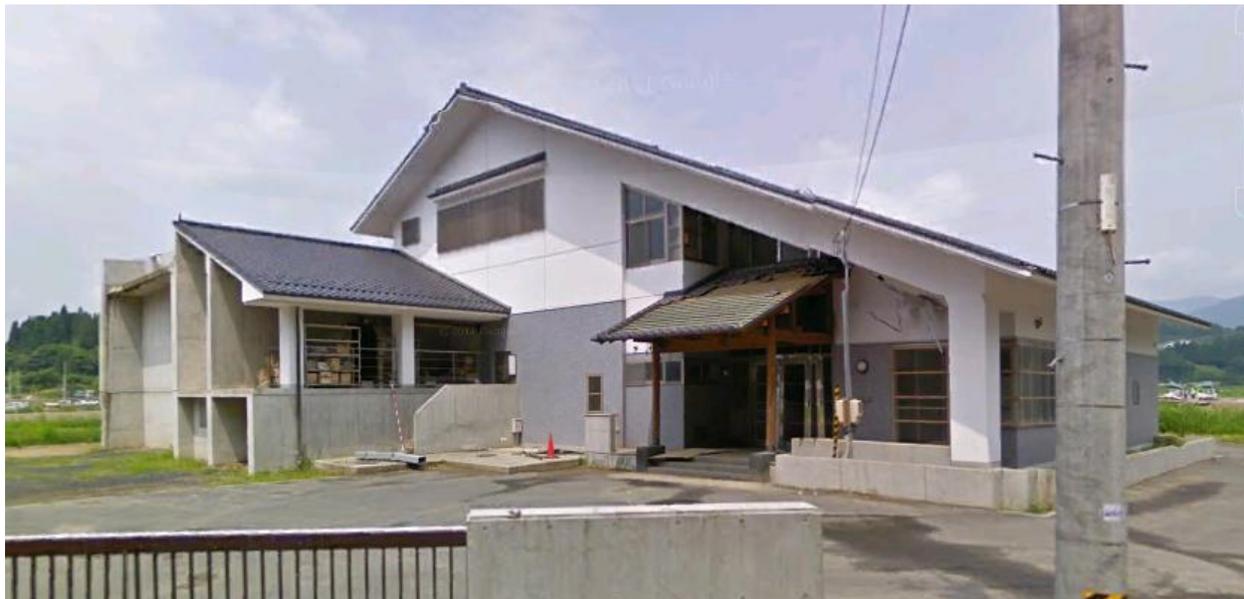
**Comments:** No catastrophic damage evident in post-event satellite imagery. Ground photos show the structure has remained relatively intact with no obvious damage.

Top Left: Post-event imagery from 4/6/11. Top Right: Post-event imagery from 3/19/12.

Bottom: Post-event ground photos showing extent of damage.

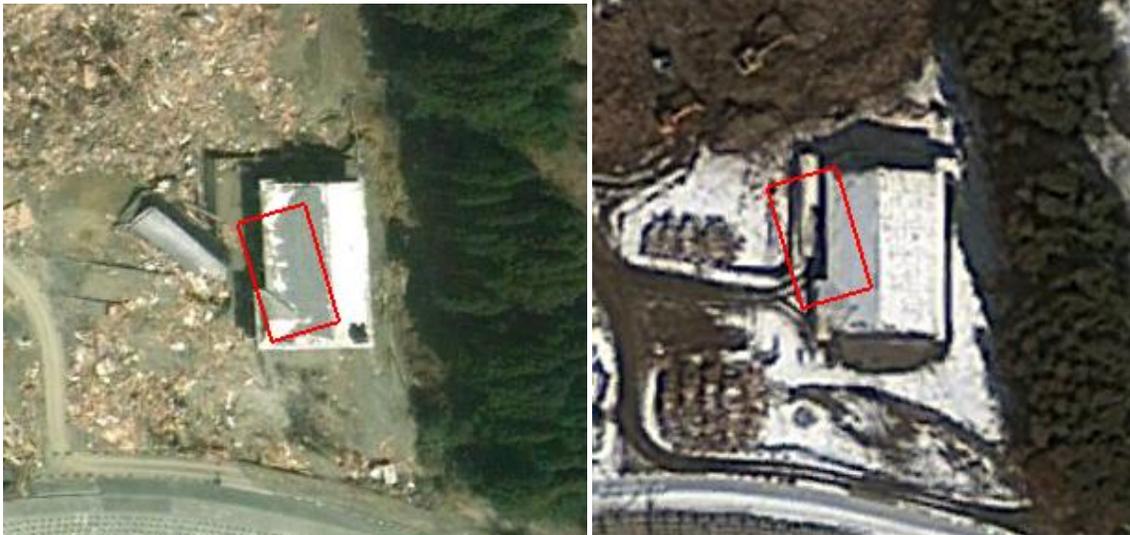
**Comments:** The surrounding structures have all been completely washed away. This particular component has no visible catastrophic damage from post-event imagery.

Left: Post-event imagery from 4/1/11. Right: Post-event imagery from 3/1/12

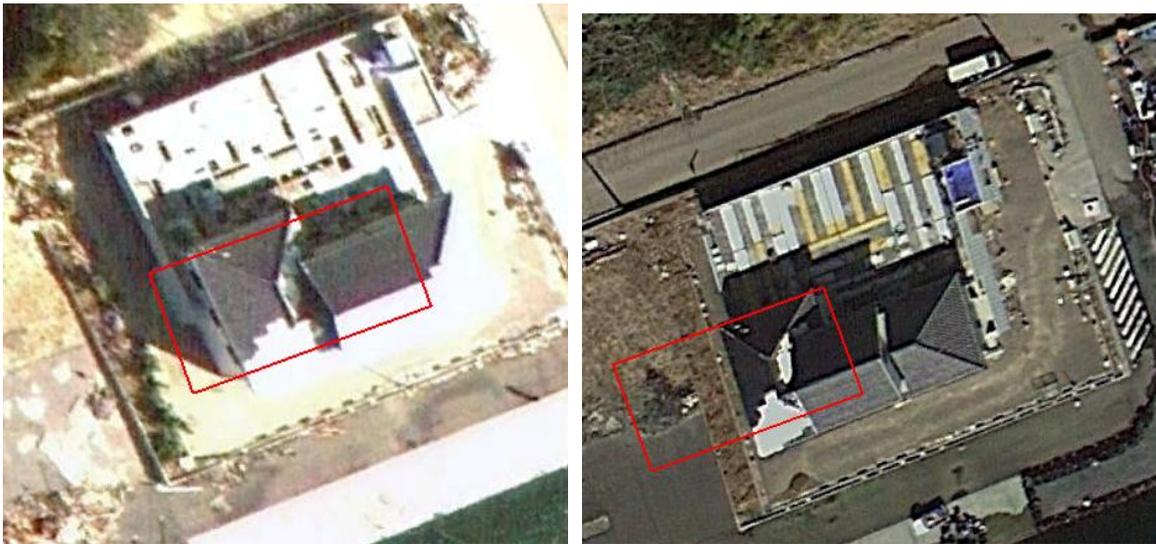
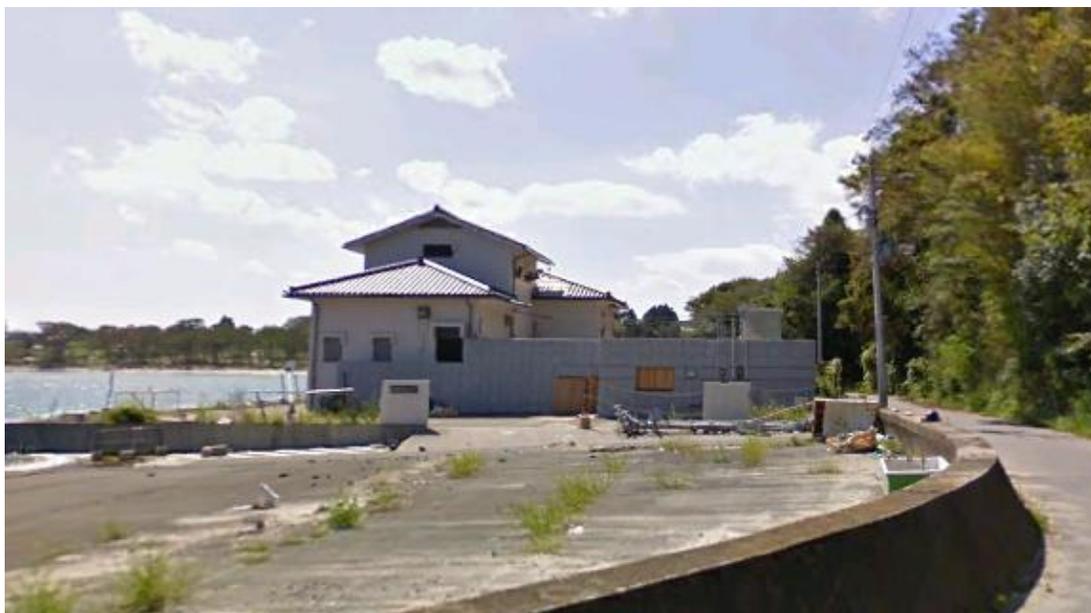
**Comments:** No catastrophic damage evident immediately following the tsunami. Post-event imagery from 3/19/12 shows clean-up has occurred around the building. No evidence of a (potential) demolition is available.

Top Left: Post-event imagery from 4/6/11. Top Right: Post-event imagery from 3/19/12.

Bottom: Post-event ground photos showing extent of damage.

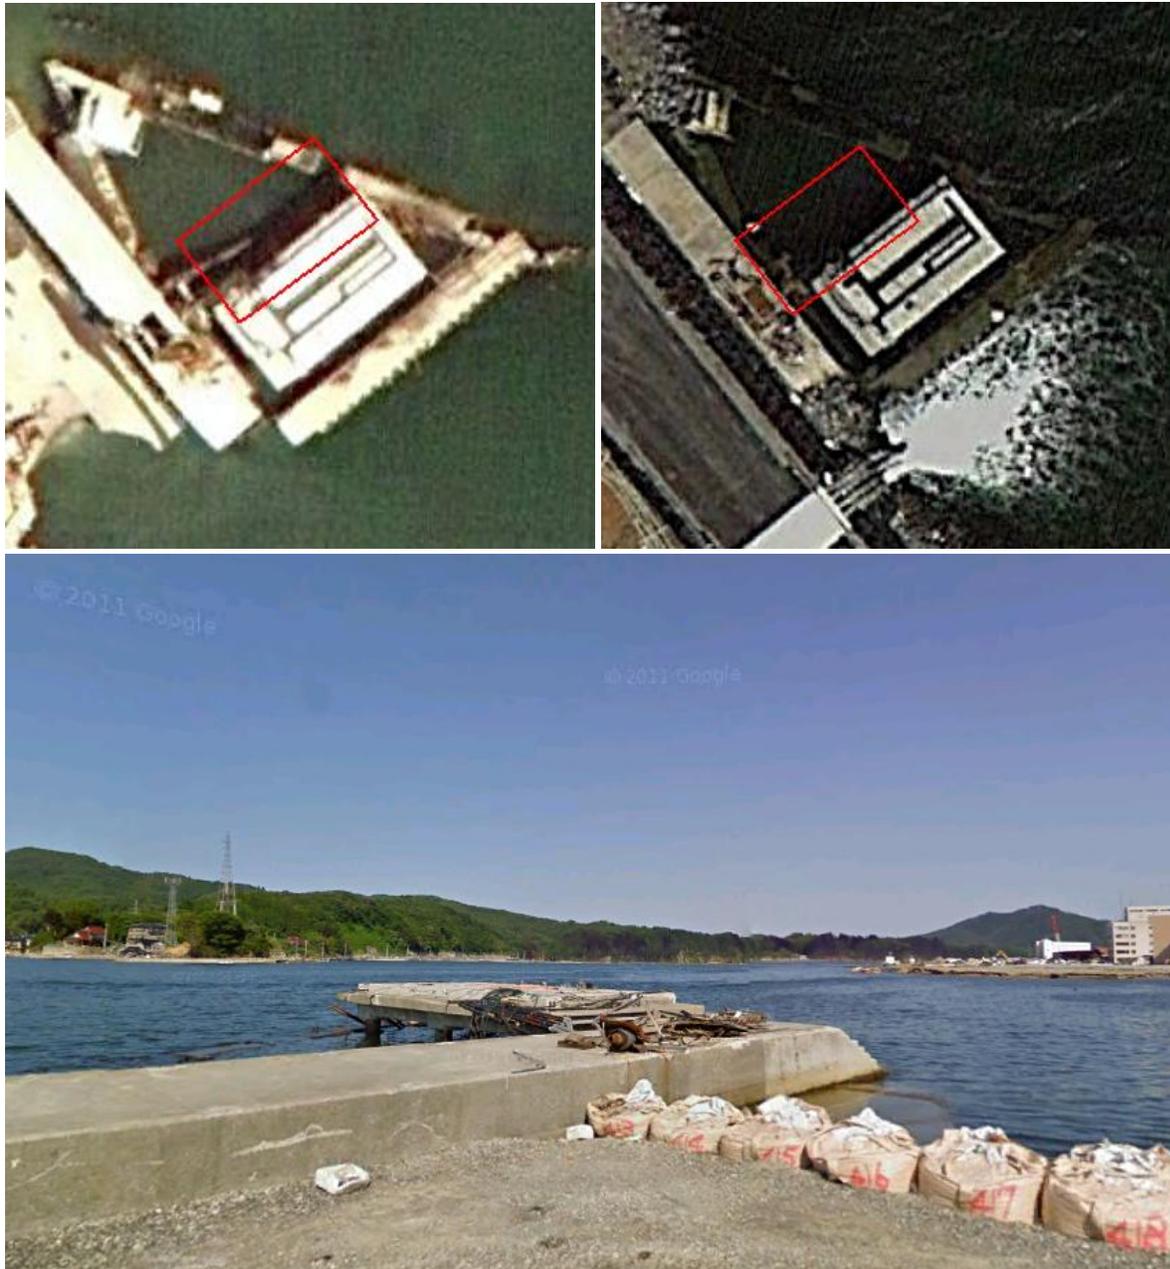
**Comments:** The structure has been demolished.

Top Left: Post-event imagery from 4/6/11. Top Right: Post-event imagery from 3/19/12.

Bottom: Ground photo showing the location of the destroyed facility.

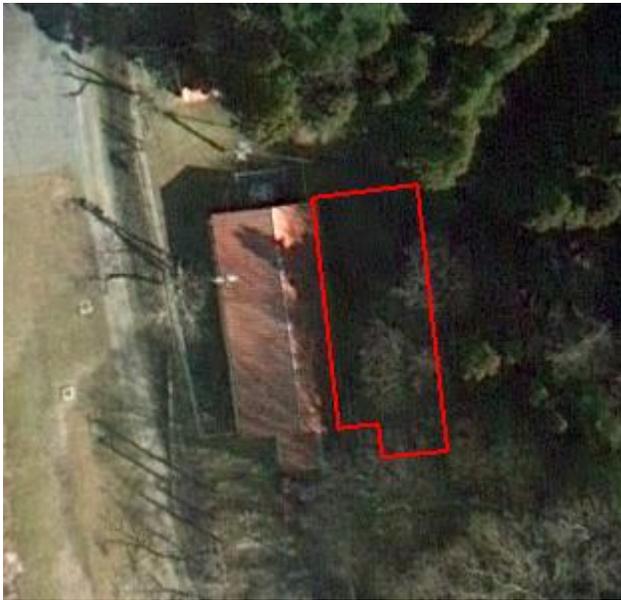
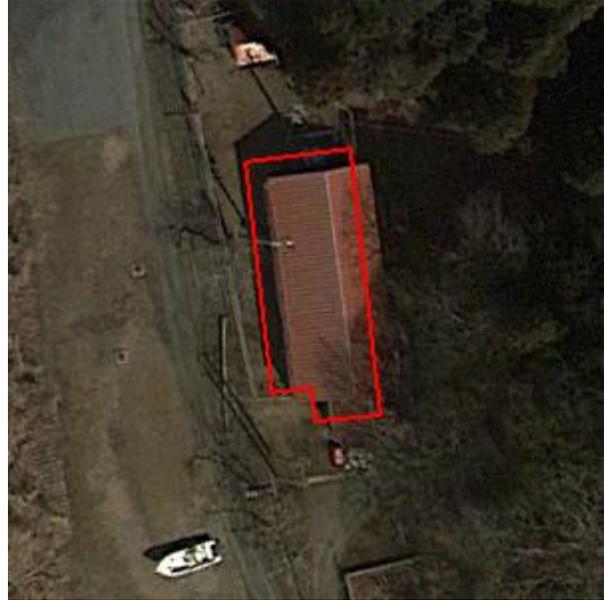
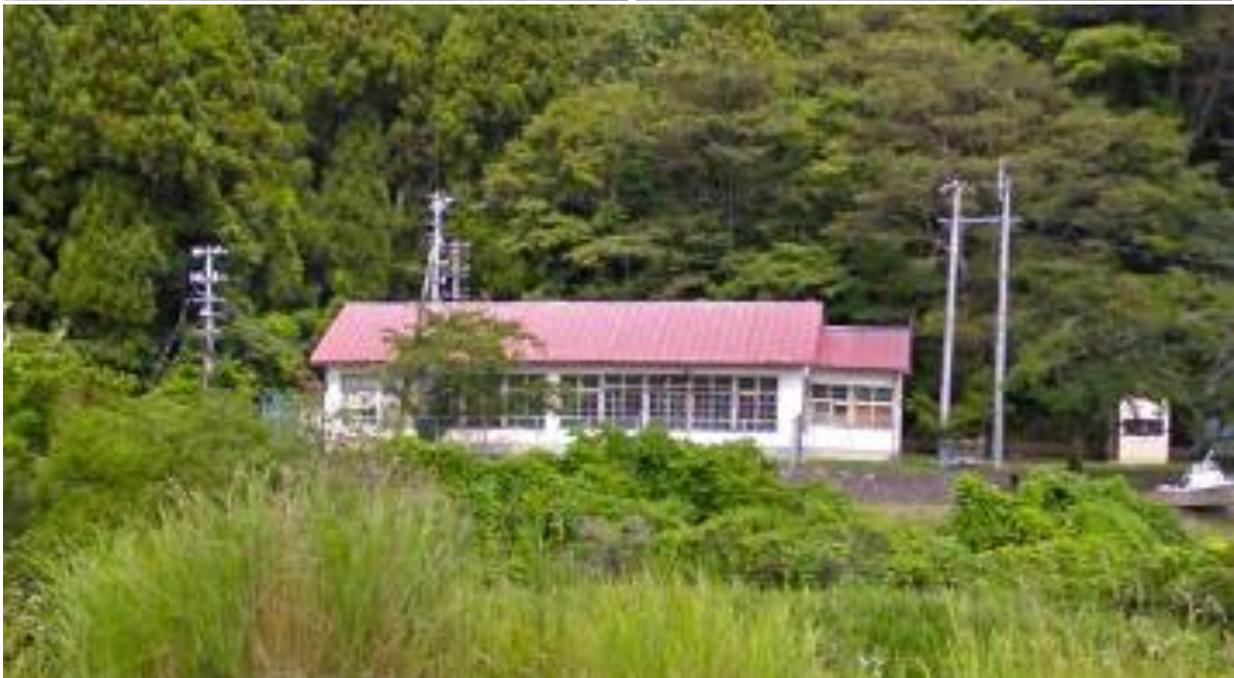
**Comments:** No catastrophic damage visible in post-event satellite imagery.

Top Left: Post-event imagery from 4/6/11. Top Right: Post-event imagery from 3/19/12.

Bottom: Post-event ground photos showing extent of damage.

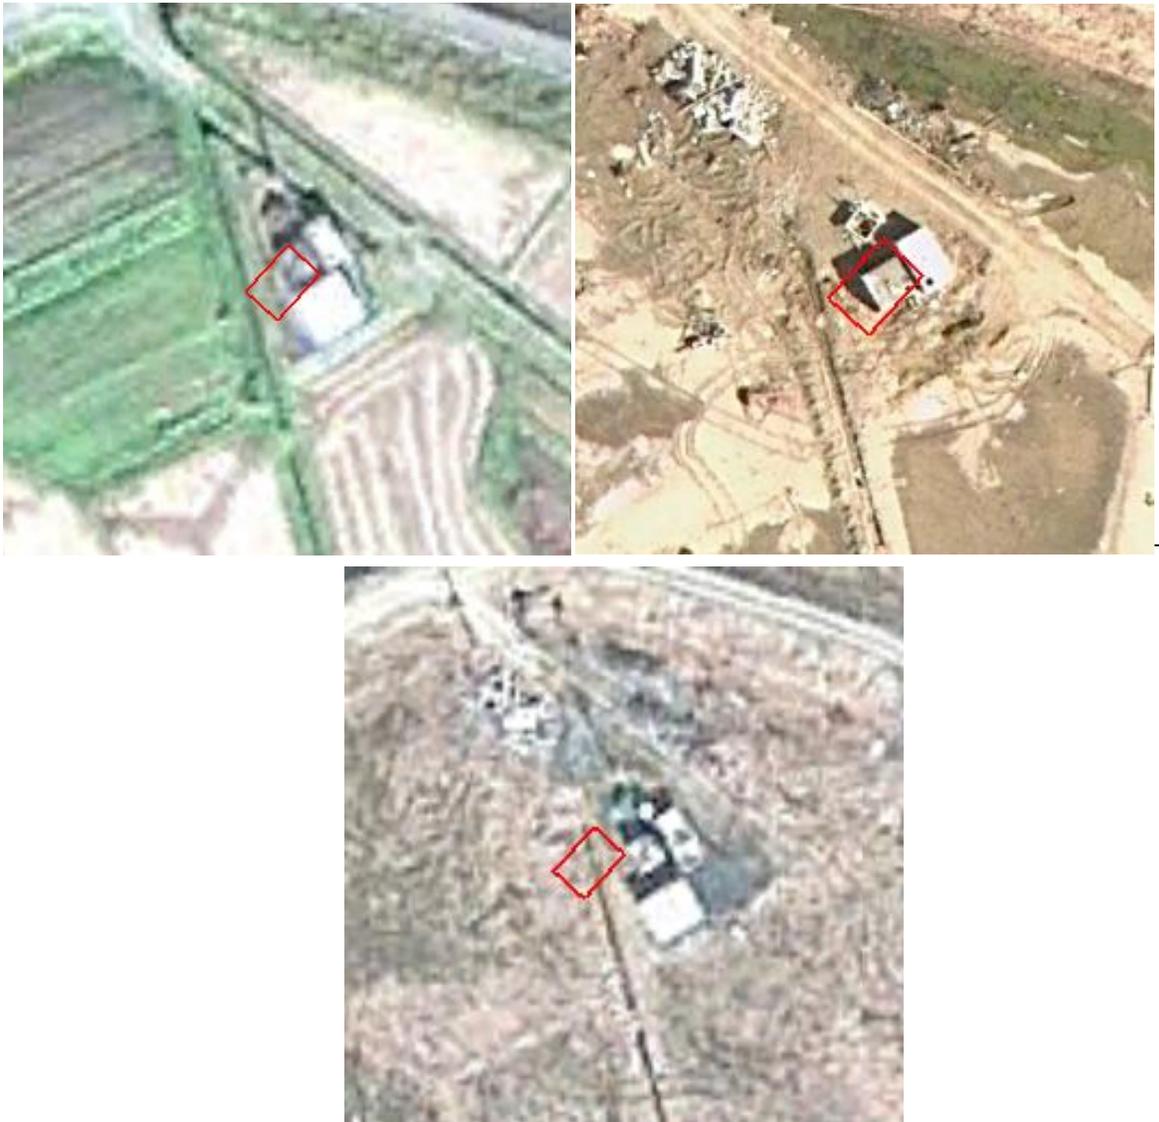
**Comments:** The structure does not appear to have experienced complete damage. Pre- and post-event imagery verify it is still standing and a demolition has not occurred.

Top Left: Pre-event imagery from 11/4/09. Top Right: Post-event imagery from 4/6/11  
Bottom: Post-event imagery from 2/22/12

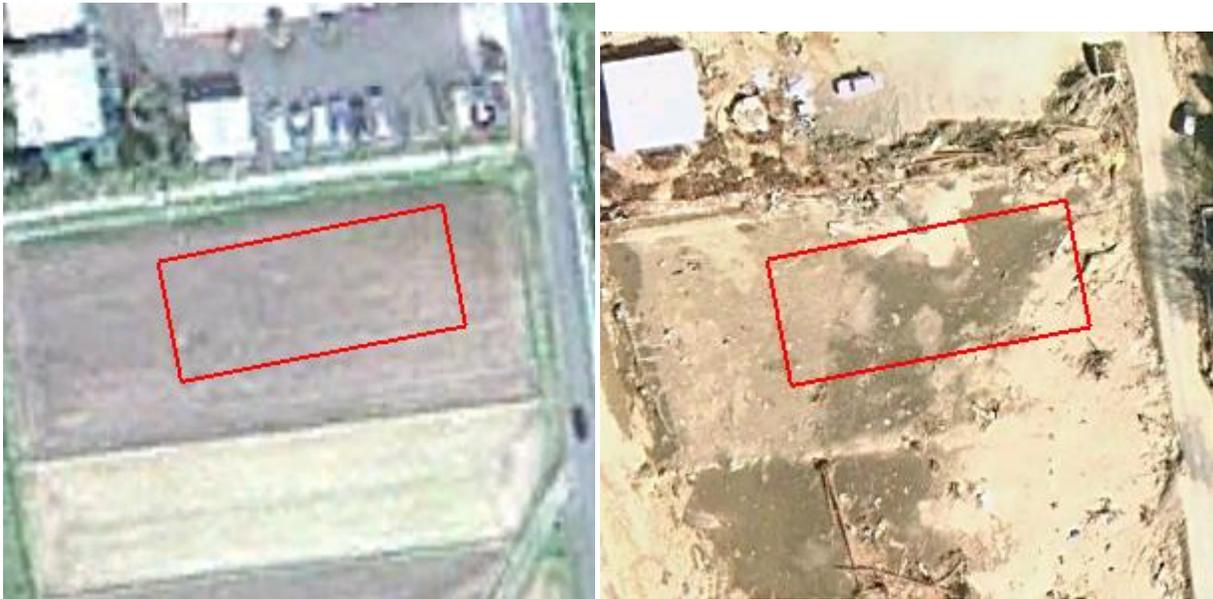
**Comments:** Cannot determine the site of the component. Pre-event imagery shows an open plot of land.

Left: Pre-event imagery from 11/4/09. Right: Post-event imagery from 4/6/11

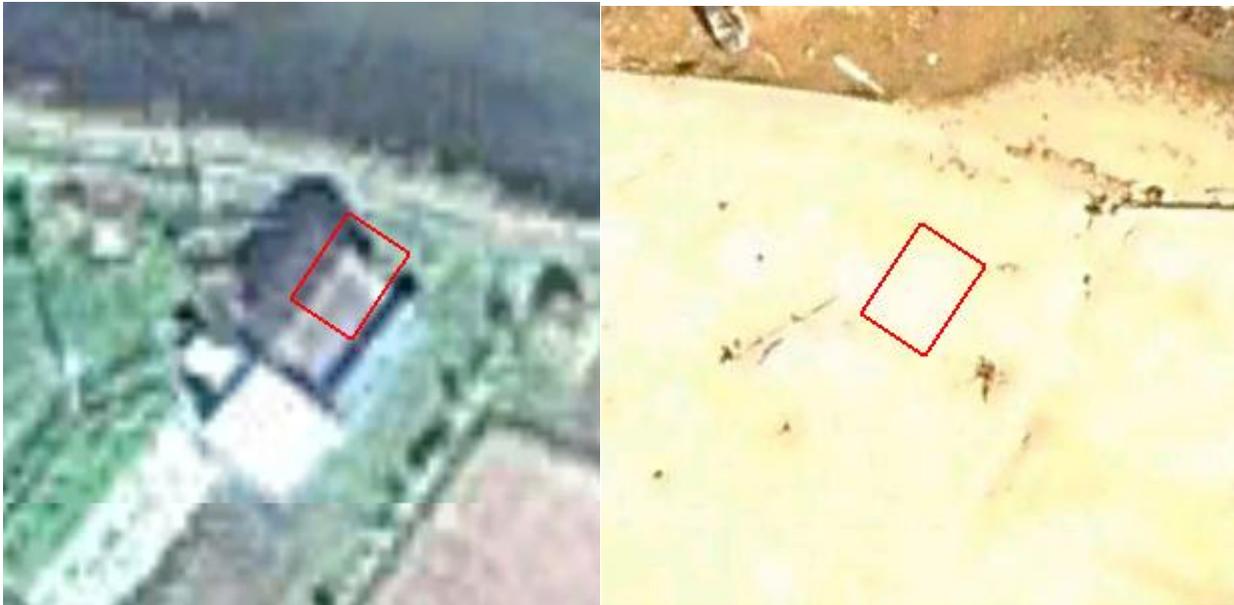
**Comments:** Structure has been washed away.

Left: Pre-event imagery from 11/4/09. Right: Post-event imagery from 4/6/11.

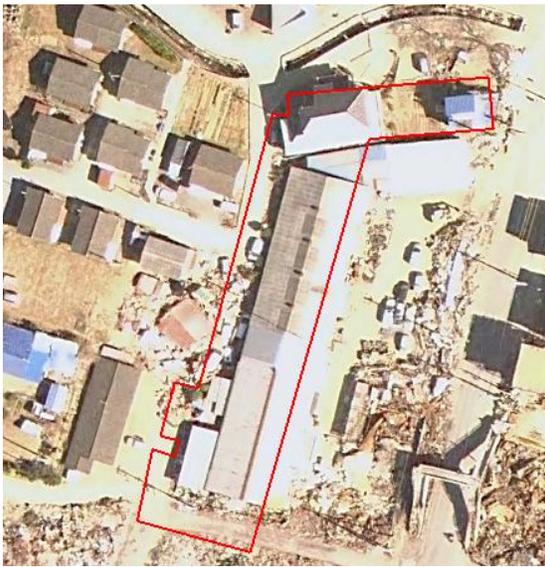
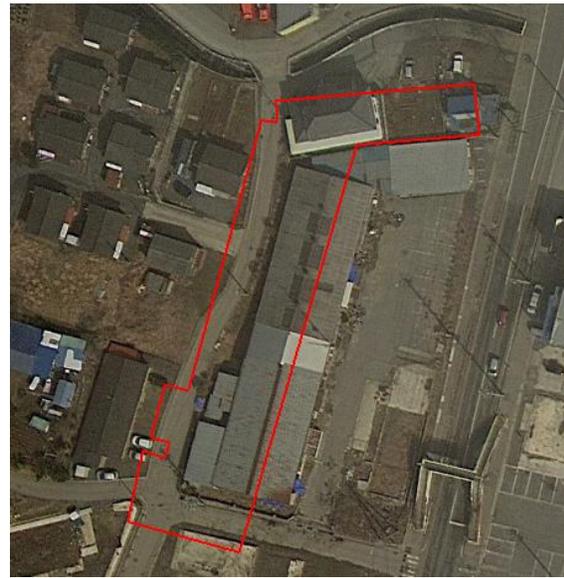
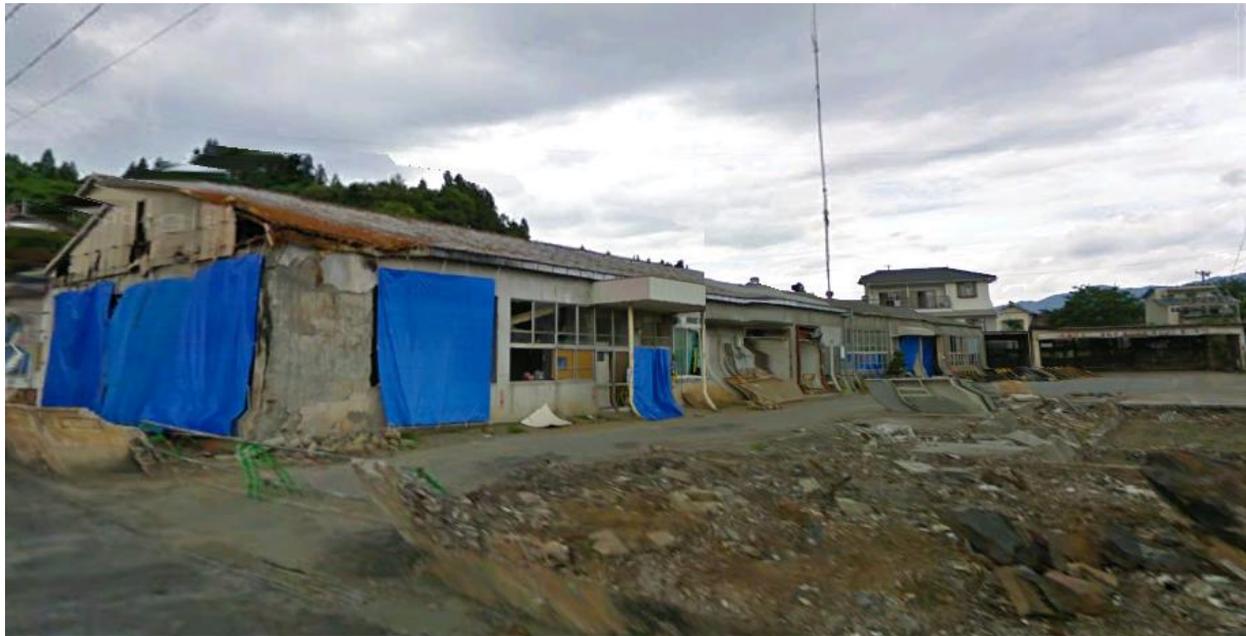
**Comments:** The facility sustained heavy damage. "Extensive" would be more a more appropriate categorization. A moderate level is assigned because of its presence over a year after the tsunami occurred.

Top Left: Post-event imagery from 4/6/11. Top Right: Post-event imagery from 3/19/12.

Bottom: Post-event ground photos showing extent of damage.
